# Access Compliance Report

## Public Rights-of-Way

### (Curb Ramps)

Intersection ID: 18038	Main Street: INWOOD_DR	Cross Street: MURRAYHILL_RD	Location: S
ADA ID: BF6E7EAD8EA3	Ramp Type: Perp	Initial Pass/Fail: Fail	Overall Compliance: No
Severity Score: 13.75			
Codes/Mitigation Info/Possible Solution		Field Measurements/Component Compliance

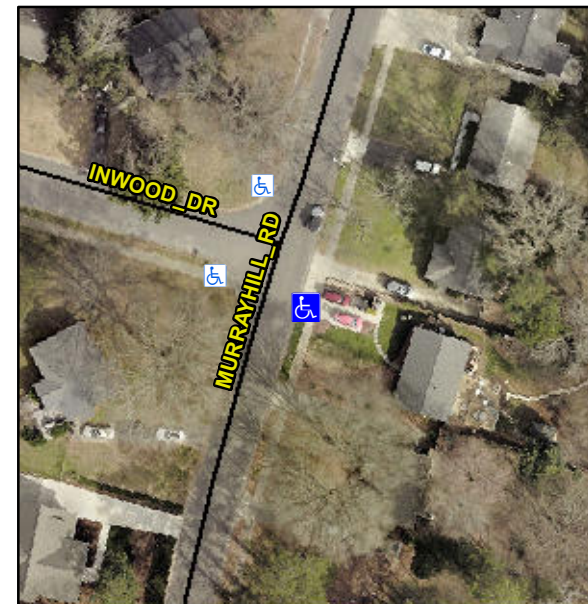
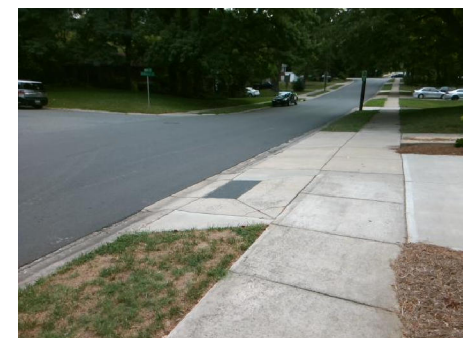
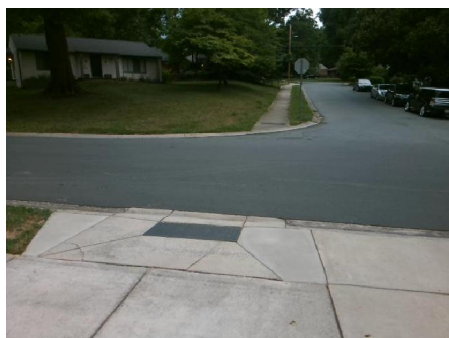
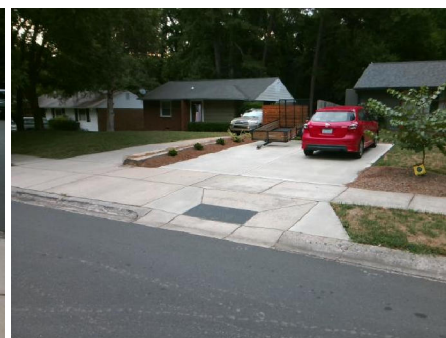
**Not Found, R304.2.2**

Compliance	Description	Data	Compliance	Description	Data
N/A	Ramp Length (in)	60.0	No	Ramp Slope (%)	9.0
Yes	Ramp Width (in)	48.0	Yes	Ramp XSlope (%)	2.4
N/A	Flare Type LT	N/A	N/A	Flare Type RT	N/A
N/A	Flare Slope LT (%)	N/A	N/A	Flare Slope RT (%)	N/A
N/A	Flare Traversable LT?	N/A	N/A	Flare Traversable RT?	N/A
N/A	Landing Length (in)	N/A	N/A	DWS Provided?	N/A
N/A	Landing Width (in)	N/A	N/A	DWS Contrast?	N/A
N/A	Landing Slope (%)	N/A	N/A	DWS Length (in)	N/A
N/A	Landing X Slope (%)	N/A	N/A	DWS Full Width?	N/A
N/A	Landing Curb? (Y/N)	N/A	N/A	DWS Offset (in)	N/A
N/A	Shared Landing?	N/A			
N/A	Gutter Ponding?	N/A	N/A	Gutter Slope (%)	N/A
N/A	Gutter Lip Ht (in)	N/A	N/A	Gutter X Slope (%)	N/A
N/A	Painted X Walk1?	No	N/A	Painted X Walk2?	N/A
	X Walk 1 Direction	To NW		X Walk 2 Direction	N/A
N/A	X Walk 1 Width (in)	N/A	N/A	X Walk 2 Width (in)	N/A
	X Walk 1 Slope (%)	5.6		X Walk 2 Slope (%)	N/A
	X Walk 1 X Slope (%)	2.5		X Walk 2 X Slope (%)	N/A

N/A	Ramp inside XWalk1?	N/A	N/A	Ramp inside XWalk2?	N/A
	Road Slope (%)	N/A	N/A	Clear Space?	N/A
	Road X Slope (%)	N/A	N/A	Clear Space to XWalk (in)	N/A
N/A	Any Obstructions?	N/A	N/A	Storm Grate/Utility Hazard?	N/A
	Obstruction Type			Storm Grate/Utility Type	
		N/A			N/A
			Yes	Surface Condition? (G/P)	Good

**Remove & Replace Entire Ramp.**
