Access Compliance Report

Public Rights-of-Way

(Curb Ramps)

Intersection ID: 51073	Main Street: RISBURG_LN	Cross Street: KEMPSFORD_DR	Location: W
ADA ID: BF72066F49DC	Ramp Type: PerpDiag	Initial Pass/Fail: Fail	Overall Compliance: No
Severity Score: 21.25			
Codes/Mitigation Info/Possible Solution		Field Measurements/Component Compliance

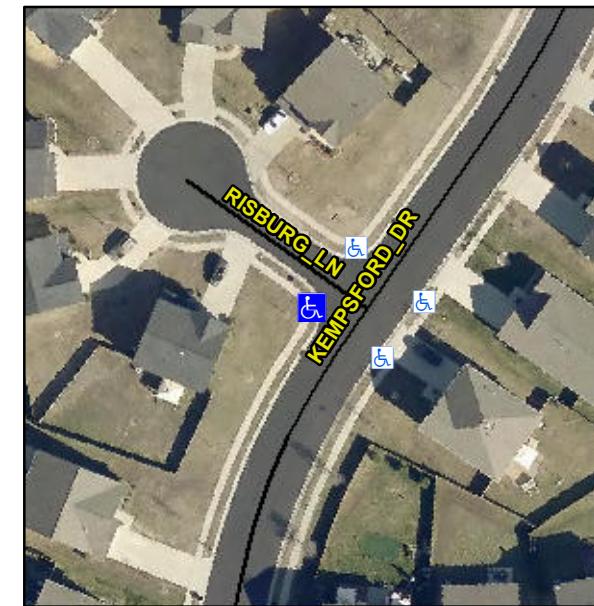
Compliance	Description	Data	Compliance	Description	Data
N/A	Ramp Length (in)	47.0	No	Ramp Slope (%)	8.7
No	Ramp Width (in)	47.0	Yes	Ramp XSlope (%)	1.3
N/A	Flare Type LT	N/A	N/A	Flare Type RT	N/A
N/A	Flare Slope LT (%)	N/A	N/A	Flare Slope RT (%)	N/A
N/A	Flare Traversable LT?	N/A	N/A	Flare Traversable RT?	N/A
N/A	Landing Length (in)	N/A	N/A	DWS Provided?	N/A
N/A	Landing Width (in)	N/A	N/A	DWS Contrast?	N/A
N/A	Landing Slope (%)	N/A	N/A	DWS Length (in)	N/A
N/A	Landing X Slope (%)	N/A	N/A	DWS Full Width?	N/A
N/A	Landing Curb? (Y/N)	N/A	N/A	DWS Offset (in)	N/A
N/A	Shared Landing?	N/A			
N/A	Gutter Ponding?	N/A	N/A	Gutter Slope (%)	N/A
N/A	Gutter Lip Ht (in)	N/A	N/A	Gutter X Slope (%)	N/A
N/A	Painted X Walk1?	No	N/A	Painted X Walk2?	No
	X Walk 1 Direction	To SE		X Walk 2 Direction	To NE
N/A	X Walk 1 Width (in)	N/A	N/A	X Walk 2 Width (in)	N/A
	X Walk 1 Slope (%)	0.6		X Walk 2 Slope (%)	0.2
	X Walk 1 X Slope (%)	0.7		X Walk 2 X Slope (%)	0.6

N/A	Ramp inside XWalk1?	N/A	N/A	Ramp inside XWalk2?	N/A
	Road Slope (%)	0.6	N/A	Clear Space?	N/A
	Road X Slope (%)	0.9	N/A	Clear Space to XWalk (in)	N/A
N/A	Any Obstructions?	N/A	N/A	Storm Grate/Utility Hazard?	N/A
	Obstruction Type			Storm Grate/Utility Type	
		N/A			N/A
			Yes	Surface Condition? (G/P)	Good

Possible Solutions:

Remove & Replace Curb Ramp With Two New Directional Ramps or Equivalent.
