Access Compliance Report

Public Rights-of-Way

(Curb Ramps)

| Intersection ID: 42559 | Main Street: ENEIDA_SUE_DR | Cross Street: LUNDY_LN | Location: | N |

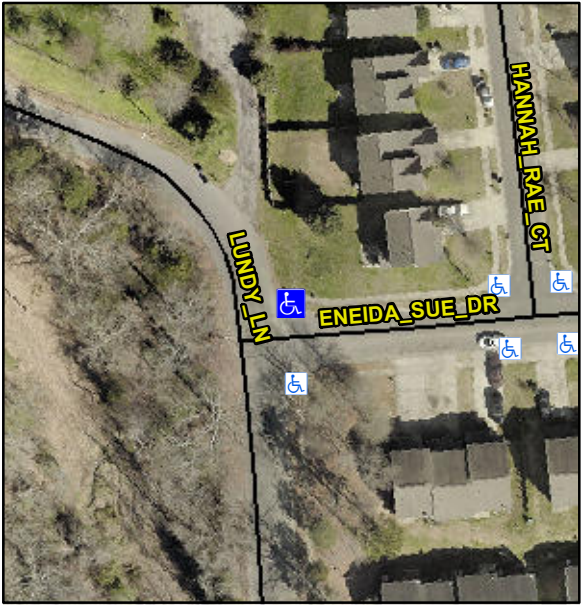
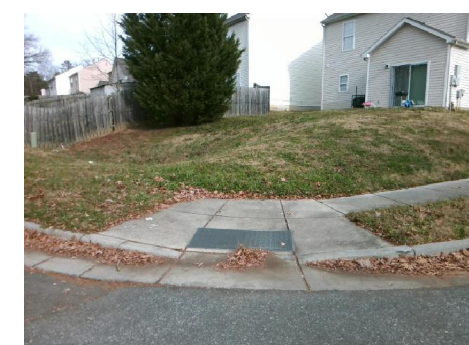
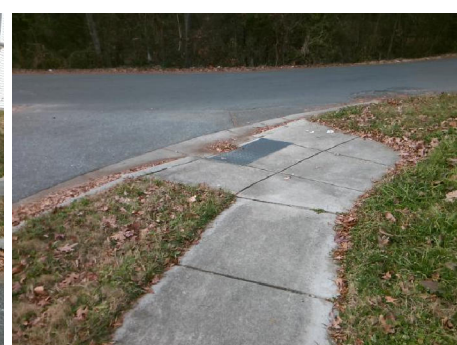
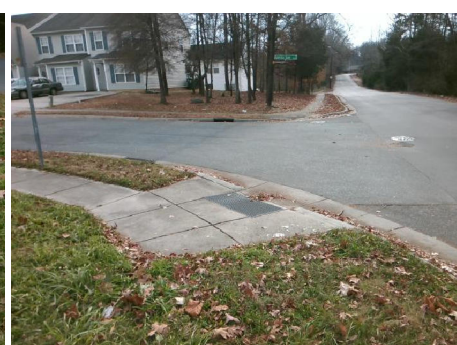
| ADA ID: BF7DF3571972 | Ramp Type: Perp | Initial Pass/Fail: Fail | Overall Compliance: No | Severity Score: 10 |

| Codes/Mitigation Info/Possible Solution | | | Field Measurements/Component Compliance | | |
|--|---|--|---|---|---|
| | | | No | Ramp Width (in) | 41.0 |
| <p>Surveyor Notes:</p> <p>N/A</p> <p>PROW/ADA:</p> <p>R304.5.1, R304.5.3</p> | | | N/A | Flare Type RT | N/A |
| | | | N/A | Gutter Ponding? | Yes |

| Codes/Mitigation Info/Possible Solution | | | Field Measurements/Component Compliance | | |
|--|---|--|---|---|---|
| | Remove & Replace Entire Ramp. | | N/A | Ramp Length (in) | 48.5 |
| <p>Total Cost:</p> <p>\$ 1850.00</p> | | | N/A | Gutter Slope (%) | N/A |
