Access Compliance Report

Public Rights-of-Way

(Curb Ramps)

Intersection ID: 49131	Main Street: EWERT_CUT_LN	Cross Street: WILTSHIRE_RIDGE_RD	Location: NW
ADA ID: BF8068E9B630	Ramp Type: Perp	Initial Pass/Fail: Fail	Overall Compliance: No
Severity Score: 33.75			
Codes/Mitigation Info/Possible Solution		Field Measurements/Component Compliance

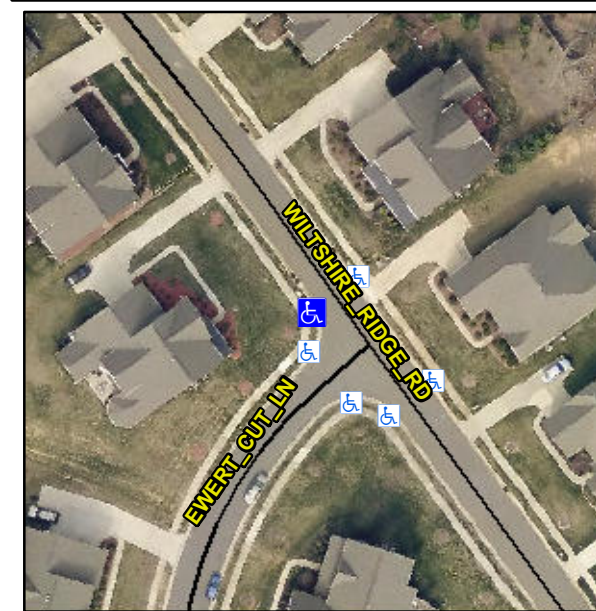
Not Found, R304.5.1, R304.5.3

Compliance	Description	Data	Compliance	Description	Data
N/A	Ramp Length (in)	46.5	Yes	Ramp Slope (%)	5.2
No	Ramp Width (in)	47.0	No	Ramp XSlope (%)	9.8
N/A	Flare Type LT	N/A	N/A	Flare Type RT	N/A
N/A	Flare Slope LT (%)	N/A	N/A	Flare Slope RT (%)	N/A
N/A	Flare Traversable LT?	N/A	N/A	Flare Traversable RT?	N/A
N/A	Landing Length (in)	N/A	N/A	DWS Provided?	N/A
N/A	Landing Width (in)	N/A	N/A	DWS Contrast?	N/A
N/A	Landing Slope (%)	N/A	N/A	DWS Length (in)	N/A
N/A	Landing X Slope (%)	N/A	N/A	DWS Full Width?	N/A
N/A	Landing Curb? (Y/N)	N/A	N/A	DWS Offset (in)	N/A
N/A	Shared Landing?	N/A			
N/A	Gutter Ponding?	N/A	N/A	Gutter Slope (%)	N/A
N/A	Gutter Lip Ht (in)	N/A	N/A	Gutter X Slope (%)	N/A
N/A	Painted X Walk1?	No	N/A	Painted X Walk2?	N/A
	X Walk 1 Direction	To NE		X Walk 2 Direction	N/A
N/A	X Walk 1 Width (in)	N/A	N/A	X Walk 2 Width (in)	N/A
	X Walk 1 Slope (%)	4.6		X Walk 2 Slope (%)	N/A
	X Walk 1 X Slope (%)	7.6		X Walk 2 X Slope (%)	N/A

N/A	Ramp inside XWalk1?	N/A	N/A	Ramp inside XWalk2?	N/A
	Road Slope (%)	N/A	N/A	Clear Space?	N/A
	Road X Slope (%)	N/A	N/A	Clear Space to XWalk (in)	N/A
N/A	Any Obstructions?	N/A	N/A	Storm Grate/Utility Hazard?	N/A
	Obstruction Type			Storm Grate/Utility Type	
		N/A			N/A
			Yes	Surface Condition? (G/P)	Good

Possible Solutions:

Remove & Replace Entire Ramp.
