# Access Compliance Report

## Public Rights-of-Way

### (Curb Ramps)

Intersection ID: 10033468	Main Street: OLD_PINEVILLE_RD	Cross Street: N/A	Location: SW
ADA ID: BF88E31BB79C	Ramp Type: PerpDiag	Initial Pass/Fail: Fail	Overall Compliance: No
Severity Score: 10			
Codes/Mitigation Info/Possible Solution		Field Measurements/Component Compliance

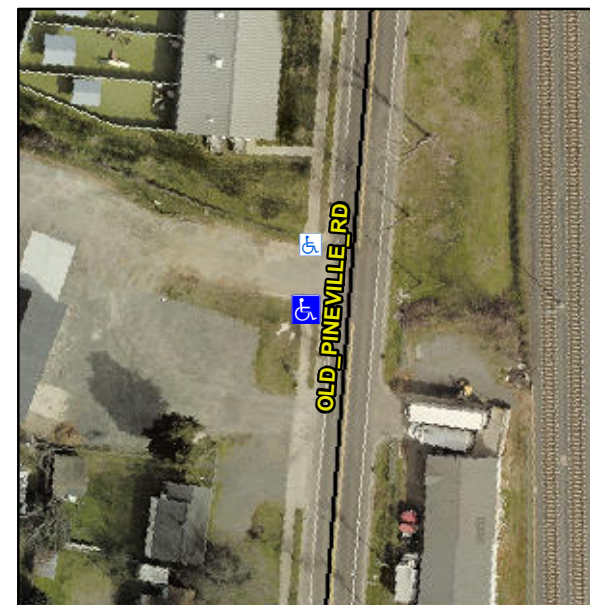
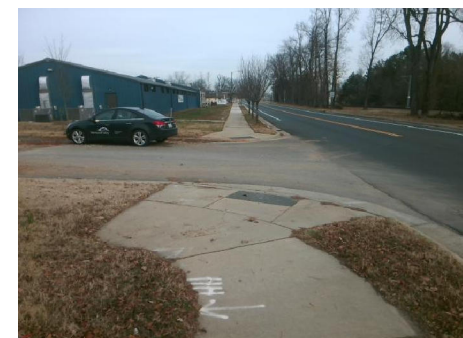
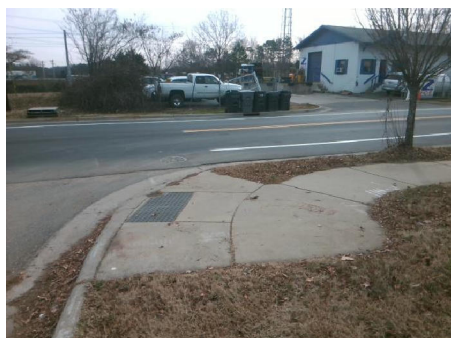
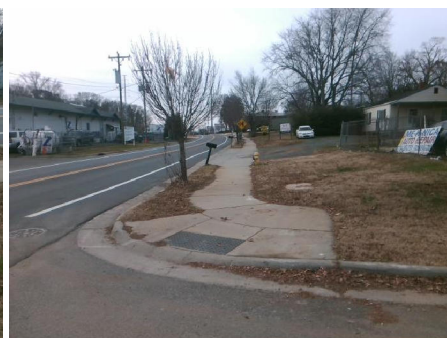
**Not Found, R304.5.1**

Compliance	Description	Data	Compliance	Description	Data
N/A	Ramp Length (in)	54.0	Yes	Ramp Slope (%)	5.2
No	Ramp Width (in)	47.0	Yes	Ramp XSlope (%)	2.2
N/A	Flare Type LT	N/A	N/A	Flare Type RT	N/A
N/A	Flare Slope LT (%)	N/A	N/A	Flare Slope RT (%)	N/A
N/A	Flare Traversable LT?	N/A	N/A	Flare Traversable RT?	N/A
N/A	Landing Length (in)	N/A	N/A	DWS Provided?	N/A
N/A	Landing Width (in)	N/A	N/A	DWS Contrast?	N/A
N/A	Landing Slope (%)	N/A	N/A	DWS Length (in)	N/A
N/A	Landing X Slope (%)	N/A	N/A	DWS Full Width?	N/A
N/A	Landing Curb? (Y/N)	N/A	N/A	DWS Offset (in)	N/A
N/A	Shared Landing?	N/A			
N/A	Gutter Ponding?	N/A	N/A	Gutter Slope (%)	N/A
N/A	Gutter Lip Ht (in)	N/A	N/A	Gutter X Slope (%)	N/A
N/A	Painted X Walk1?	No	N/A	Painted X Walk2?	No
	X Walk 1 Direction	To E		X Walk 2 Direction	To N
N/A	X Walk 1 Width (in)	N/A	N/A	X Walk 2 Width (in)	N/A
	X Walk 1 Slope (%)	0.6		X Walk 2 Slope (%)	1.9
	X Walk 1 X Slope (%)	0.5		X Walk 2 X Slope (%)	2.8

N/A	Ramp inside XWalk1?	N/A	N/A	Ramp inside XWalk2?	N/A
	Road Slope (%)	2.3	N/A	Clear Space?	N/A
	Road X Slope (%)	4.4	N/A	Clear Space to XWalk (in)	N/A
N/A	Any Obstructions?	N/A	N/A	Storm Grate/Utility Hazard?	N/A
	Obstruction Type			Storm Grate/Utility Type	
		N/A			N/A
			Yes	Surface Condition? (G/P)	Good

Possible Solutions:

**Remove & Replace Curb Ramp With Two New Directional Ramps or Equivalent.**
