Access Compliance Report

Public Rights-of-Way

(Curb Ramps)

Intersection ID: 10759	Main Street: SPRATT_ST	Cross Street: OLIVER_ST	Location: SW
ADA ID: BF9552408016	Ramp Type: Directional1	Initial Pass/Fail: Fail	Overall Compliance: No
			Severity Score: 41.25

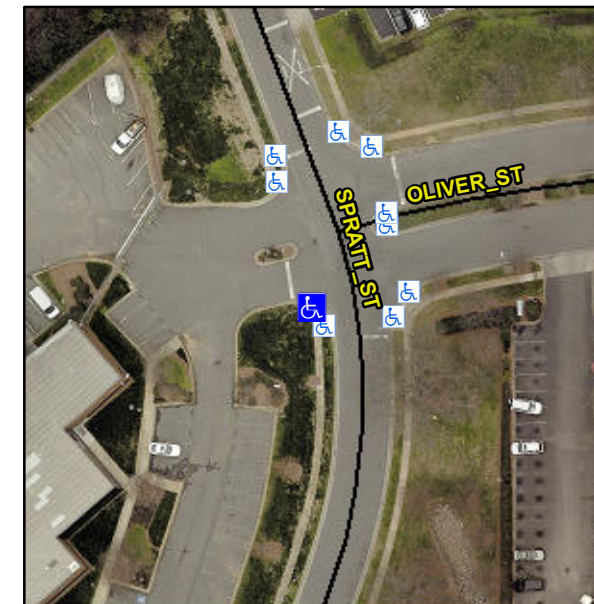
CRACK RAMP

R304.2.2, R304.5.3, R302.7

Compliance	Description	Data	Compliance	Description	Data
N/A	Ramp Length (in)	71.0	N/A	Grade Break?	N/A
Yes	Ramp Width (in)	48.0	N/A	Grade Break Slope (%)	0.0
No	Ramp Slope (%)	13.3	N/A	Grade Break XSlope (%)	0.0
No	Ramp XSlope (%)	4.1			
N/A	Flare Type LT	N/A	N/A	Flare Type RT	N/A
N/A	Flare Slope LT (%)	N/A	N/A	Flare Slope RT (%)	0.0
N/A	Flare Traversable LT?	N/A	N/A	Flare Traversable RT?	N/A
N/A	Landing Length (in)	0.0	N/A	DWS Provided?	N/A
N/A	Landing Width (in)	0.0	N/A	DWS Contrast?	N/A
N/A	Landing Slope (%)	0.0	N/A	DWS Length (in)	N/A
N/A	Landing X Slope (%)	0.0	N/A	DWS Full Width?	N/A
N/A	Landing Curb? (Y/N)	N/A	N/A	DWS Offset LT (in)	N/A
N/A	Shared Landing?	N/A	N/A	DWS Offset RT (in)	N/A
N/A	Gutter Ponding?	0.0	N/A	Gutter Slope (%)	N/A
N/A	Gutter Lip Ht (in)	1.5	N/A	Gutter X Slope (%)	N/A
N/A	Painted X Walk1?	No		Road Slope (%)	2.9
	X Walk 1 Direction	To N		Road X Slope (%)	3.1
	X Walk 1 Width (in)	N/A		Clear Space?	N/A

X Walk 1 Slope (%)	2.9	N/A	Clear Space to XWalk (in)	N/A
	X Walk 1 X Slope (%)	3.1	N/A	Storm Grate/Utility Hazard?	N/A
N/A	Ramp inside XWalk1?	N/A		Storm Grate/Utility Type	
N/A	Any Obstructions?	N/A			N/A
	Obstruction Type		No	Surface Condition? (G/P)	Poor
			N/A	Curb Slope (%)	19.3

Remove & Replace Entire Ramp.
