Access Compliance Report Public Rights-of-Way (Curb Ramps)

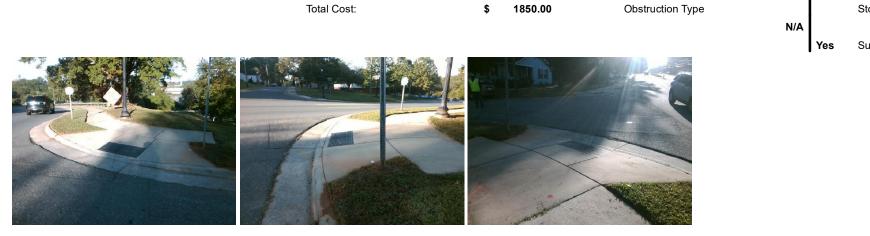
_					/
Intersection ID: 11422	Main Street: N_MCDOWELL_ST			Cross Street: PARKWOOD_AV					Location:	NW
ADA ID: BF998006856B	B Ramp Type: Perp			Initial Pass/Fail: Fail Overall Com			ompliar	mpliance: No Severity Score		21.25
Codes/Mitigation Info/Possible Solution				Field Measurements/Component Compliance						
	ansale a second	Possible Solutions:		Compliance Description			Data Compliance Description			Data
		Remove & Replace	Entire Ramp.	N/	A	Ramp Length (in)	63.5	No	Ramp Slope (%)	9.9
	1 to 10		•	No)	Ramp Width (in)	45.0	Yes	Ramp XSlope (%)	1.4
	ally man	5		N/.	A	Flare Type LT	N/A	N/A	Flare Type RT	N/A

- 44				N/	Α	Flare Slope LT (%)	N/A	N/A	Flare Slope RT (%)	N/A
	Is Alla			N/	Α	Flare Traversable LT?	N/A	N/A	Flare Traversable RT?	N/A
	Stand Maria			N/	Α	Landing Length (in)	N/A	N/A	DWS Provided?	N/A
A CONTRACT OF A		Surveyor Notes:		N/	Α	Landing Width (in)	N/A	N/A	DWS Contrast?	N/A
to a second s	6	N/A		N/	Α	Landing Slope (%)	N/A	N/A	DWS Length (in)	N/A
8				N/	Α	Landing X Slope (%)	N/A	N/A	DWS Full Width?	N/A
St G	ARKINOOD AV			N/		Landing Curb? (Y/N)	N/A	N/A	DWS Offset (in)	N/A
1				N/	Α	Shared Landing?	N/A			
the state of the s	11	PROW/ADA:		N/	Α	Gutter Ponding?	N/A	N/A	Gutter Slope (%)	N/A
all and I in	4. KA	Not Found, R304.5.	1 R304 2 2	N/	A	Gutter Lip Ht (in)	1.0	N/A	Gutter X Slope (%)	N/A
Strange 12	Assa -		,,,,,,,,,,,,,,,,,,,,,,,,,,,,,,,,,,,,,,,	N/	Α	Painted X Walk1?	No	N/A	Painted X Walk2?	N/A
						X Walk 1 Direction	To E		X Walk 2 Direction	N/A
			N/	Α	X Walk 1 Width (in)	N/A	N/A	X Walk 2 Width (in)	N/A
