Access Compliance Report

Public Rights-of-Way

(Curb Ramps)

Intersection ID: 26392	Main Street: BEVINGTON_PL	Cross Street: BRECHIN_DR	Location: NE
ADA ID: BF9AF3995E87	Ramp Type: Perp	Initial Pass/Fail: Fail	Overall Compliance: No
		Severity Score: 22.5

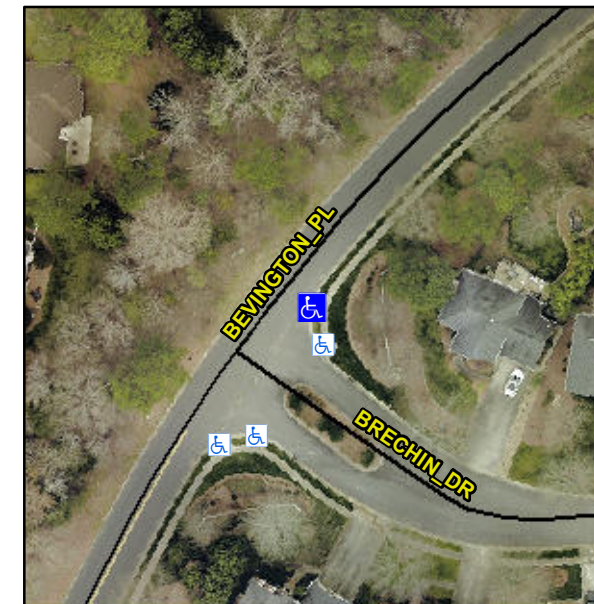
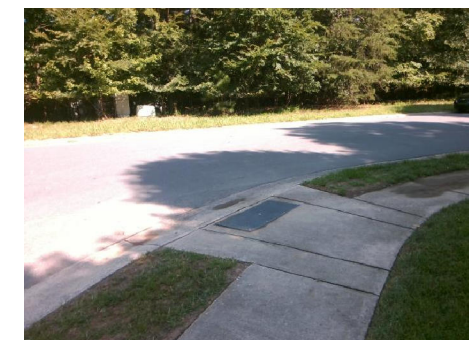
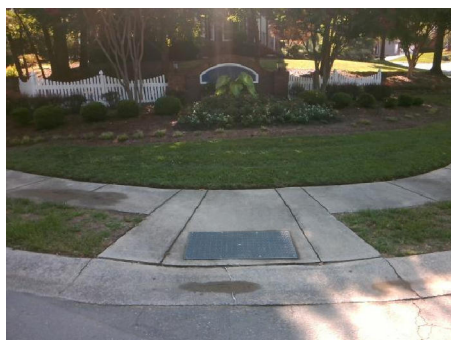
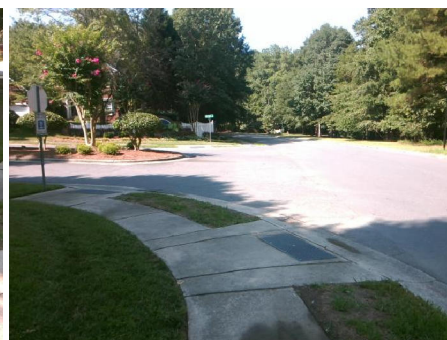
Not Found, R304.5.1, R304.2.2, R304.5.3

Compliance	Description	Data	Compliance	Description	Data
N/A	Ramp Length (in)	93.0	No	Ramp Slope (%)	8.6
No	Ramp Width (in)	44.0	No	Ramp XSlope (%)	2.1
N/A	Flare Type LT	N/A	N/A	Flare Type RT	N/A
N/A	Flare Slope LT (%)	N/A	N/A	Flare Slope RT (%)	N/A
N/A	Flare Traversable LT?	N/A	N/A	Flare Traversable RT?	N/A
N/A	Landing Length (in)	N/A	N/A	DWS Provided?	N/A
N/A	Landing Width (in)	N/A	N/A	DWS Contrast?	N/A
N/A	Landing Slope (%)	N/A	N/A	DWS Length (in)	N/A
N/A	Landing X Slope (%)	N/A	N/A	DWS Full Width?	N/A
N/A	Landing Curb? (Y/N)	N/A	N/A	DWS Offset (in)	N/A
N/A	Shared Landing?	N/A			
N/A	Gutter Ponding?	N/A	N/A	Gutter Slope (%)	N/A
N/A	Gutter Lip Ht (in)	N/A	N/A	Gutter X Slope (%)	N/A
N/A	Painted X Walk1?	No	N/A	Painted X Walk2?	N/A
	X Walk 1 Direction	To NW		X Walk 2 Direction	N/A
N/A	X Walk 1 Width (in)	N/A	N/A	X Walk 2 Width (in)	N/A
	X Walk 1 Slope (%)	4.5		X Walk 2 Slope (%)	N/A
	X Walk 1 X Slope (%)	1.7		X Walk 2 X Slope (%)	N/A

N/A	Ramp inside XWalk1?	N/A	N/A	Ramp inside XWalk2?	N/A
	Road Slope (%)	N/A	N/A	Clear Space?	N/A
	Road X Slope (%)	N/A	N/A	Clear Space to XWalk (in)	N/A
N/A	Any Obstructions?	N/A	N/A	Storm Grate/Utility Hazard?	N/A
	Obstruction Type			Storm Grate/Utility Type	
		N/A			N/A
			Yes	Surface Condition? (G/P)	Good

Remove & Replace Entire Ramp.
