# Access Compliance Report

## Public Rights-of-Way

### (Curb Ramps)

| Intersection ID: 24855 | Main Street: MACANDREW_DR | Cross Street: TWYNHAM_LN | Location: E |

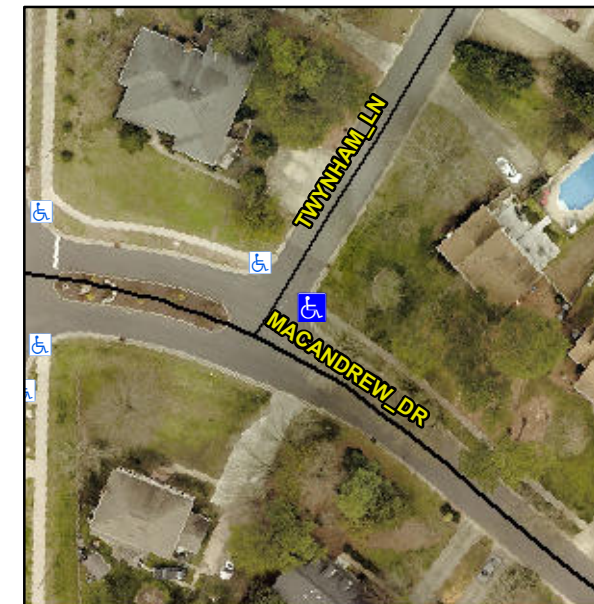
| ADA ID: BF9BFA6AEFDF | Ramp Type: PerpDiag | Initial Pass/Fail: Fail | Overall Compliance: No |
| | | Severity Score: 10 | |

**Not Found, R304.5.1, R304.5.3**

| Compliance | Description | Data | Compliance | Description | Data |
|---|---|---|---|---|---|
| N/A | Ramp Length (in) | 63.0 | Yes | Ramp Slope (%) | 8.1 |
| No | Ramp Width (in) | 44.0 | No | Ramp XSlope (%) | 2.7 |

**Remove & Replace Curb Ramp With Two New Directional Ramps or Equivalent.**

Total Cost: \$ 3200.00
