# Access Compliance Report

## Public Rights-of-Way

### (Curb Ramps)

Intersection ID: 50664	Main Street: WITHERS_RD	Cross Street: CRAIGHILL_LN	Location: NW
ADA ID: BFA34878A14C	Ramp Type: Perp	Initial Pass/Fail: Fail	Overall Compliance: No
Severity Score: 12.5			
Codes/Mitigation Info/Possible Solution		Field Measurements/Component Compliance

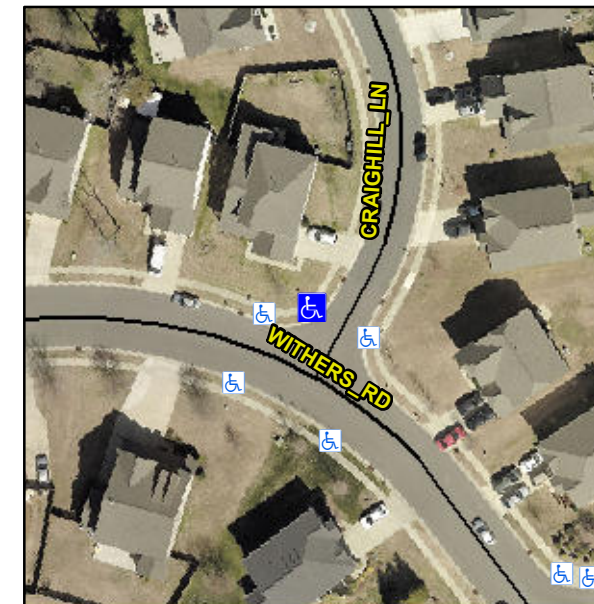
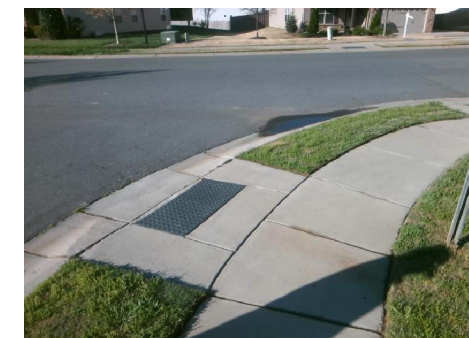
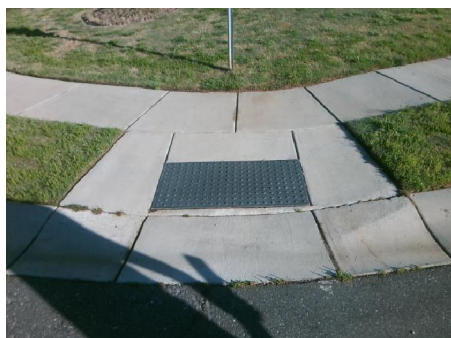
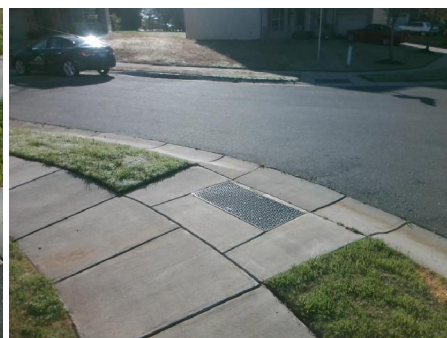
Compliance	Description	Data	Compliance	Description	Data
N/A	Ramp Length (in)	48.0	No	Ramp Slope (%)	8.7
Yes	Ramp Width (in)	48.0	Yes	Ramp XSlope (%)	0.3
N/A	Flare Type LT	N/A	N/A	Flare Type RT	N/A
N/A	Flare Slope LT (%)	N/A	N/A	Flare Slope RT (%)	N/A
N/A	Flare Traversable LT?	N/A	N/A	Flare Traversable RT?	N/A
N/A	Landing Length (in)	N/A	N/A	DWS Provided?	N/A
N/A	Landing Width (in)	N/A	N/A	DWS Contrast?	N/A
N/A	Landing Slope (%)	N/A	N/A	DWS Length (in)	N/A
N/A	Landing X Slope (%)	N/A	N/A	DWS Full Width?	N/A
N/A	Landing Curb? (Y/N)	N/A	N/A	DWS Offset (in)	N/A
N/A	Shared Landing?	N/A			
N/A	Gutter Ponding?	N/A	N/A	Gutter Slope (%)	N/A
N/A	Gutter Lip Ht (in)	N/A	N/A	Gutter X Slope (%)	N/A
N/A	Painted X Walk1?	No	N/A	Painted X Walk2?	N/A
	X Walk 1 Direction	To SE		X Walk 2 Direction	N/A
N/A	X Walk 1 Width (in)	N/A	N/A	X Walk 2 Width (in)	N/A
	X Walk 1 Slope (%)	0.5		X Walk 2 Slope (%)	N/A
	X Walk 1 X Slope (%)	3.8		X Walk 2 X Slope (%)	N/A

N/A	Ramp inside XWalk1?	N/A	N/A	Ramp inside XWalk2?	N/A
	Road Slope (%)	N/A	N/A	Clear Space?	N/A
	Road X Slope (%)	N/A	N/A	Clear Space to XWalk (in)	N/A
N/A	Any Obstructions?	N/A	N/A	Storm Grate/Utility Hazard?	N/A
	Obstruction Type			Storm Grate/Utility Type	
		N/A			N/A
			Yes	Surface Condition? (G/P)	Good

**Remove & Replace Entire Ramp.**

**R304.2.2**
