# Access Compliance Report

## Public Rights-of-Way

### (Curb Ramps)

Intersection ID: 2719	Main Street: BEAUVISTA_DR	Cross Street: FAIRVISTA_DR	Location: NW
ADA ID: BFB3FCD0FE15	Ramp Type: PerpDiag	Initial Pass/Fail: Fail	Overall Compliance: No
		Severity Score: 12.5

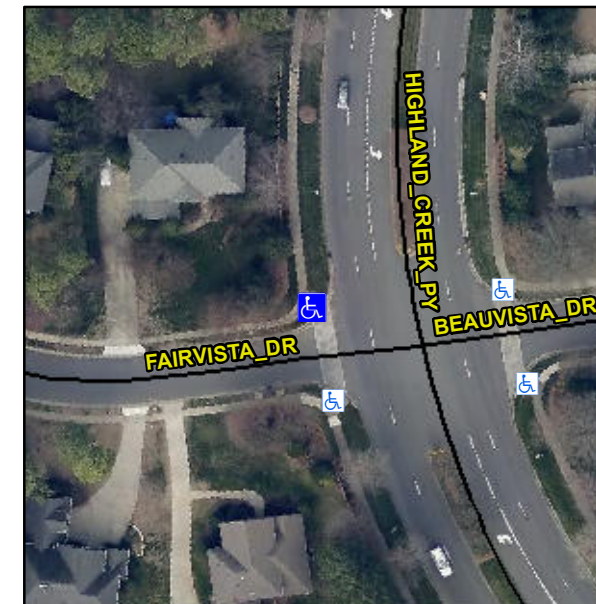
Compliance	Description	Data	Compliance	Description	Data
N/A	Ramp Length (in)	76.0	No	Ramp Slope (%)	8.5
Yes	Ramp Width (in)	48.0	Yes	Ramp XSlope (%)	0.4
N/A	Flare Type LT	N/A	N/A	Flare Type RT	N/A
N/A	Flare Slope LT (%)	N/A	N/A	Flare Slope RT (%)	N/A
N/A	Flare Traversable LT?	N/A	N/A	Flare Traversable RT?	N/A
N/A	Landing Length (in)	N/A	N/A	DWS Provided?	N/A
N/A	Landing Width (in)	N/A	N/A	DWS Contrast?	N/A
N/A	Landing Slope (%)	N/A	N/A	DWS Length (in)	N/A
N/A	Landing X Slope (%)	N/A	N/A	DWS Full Width?	N/A
N/A	Landing Curb? (Y/N)	N/A	N/A	DWS Offset (in)	N/A
N/A	Shared Landing?	N/A			
N/A	Gutter Ponding?	N/A	N/A	Gutter Slope (%)	N/A
N/A	Gutter Lip Ht (in)	N/A	N/A	Gutter X Slope (%)	N/A
N/A	Painted X Walk1?	No	N/A	Painted X Walk2?	No
	X Walk 1 Direction	To E		X Walk 2 Direction	To S
N/A	X Walk 1 Width (in)	N/A	N/A	X Walk 2 Width (in)	N/A
	X Walk 1 Slope (%)	2.3		X Walk 2 Slope (%)	2.4
	X Walk 1 X Slope (%)	0.1		X Walk 2 X Slope (%)	1.4

N/A	Ramp inside XWalk1?	N/A	N/A	Ramp inside XWalk2?	N/A
	Road Slope (%)	0.9	N/A	Clear Space?	N/A
	Road X Slope (%)	1.1	N/A	Clear Space to XWalk (in)	N/A
N/A	Any Obstructions?	N/A	N/A	Storm Grate/Utility Hazard?	N/A
	Obstruction Type			Storm Grate/Utility Type	
		N/A			N/A
		Yes		Surface Condition? (G/P)	Good

**Remove & Replace Curb Ramp With Two New Directional Ramps or Equivalent.**

**Not Found, R304.2.2**

Total Cost: \$ 3200.00
