Access Compliance Report Public Rights-of-Way (Curb Ramps)

Intersection ID: 42483 Main Street: BLAKENEY_GREENS_BV			Cross	Cross Street: BULLOCK_GREENWAY_BV				Location:	SW
ADA ID: BFBB16E3B9C9 Ramp Type: PerpDiag			Initial	nitial Pass/Fail: Fail Overall Compliance: No				o Severity Score:	17.5
Codes/Mitigation Info/Possible Solution				Field Measurements/Component Compliance					
		Possible Solutions:		Compliance Description			Data Compliance Description		
The star 20		Remove & Replace Curb Ran	With	N/A	Ramp Length (in)	67.0	Yes	Ramp Slope (%)	5.1
		Two New Directional Ramps or		No	Ramp Width (in)	35.0	Yes	Ramp XSlope (%)	1.6
11307		Equivalent.		N/A	Flare Type LT	N/A	N/A	Flare Type RT	N/A
Mark H	Sen Cas			N/A	Flare Slope LT (%)	N/A	N/A	Flare Slope RT (%)	N/A
	the second second			N/A	Flare Traversable LT?	N/A	N/A	Flare Traversable RT?	N/A
the second				N/A	Landing Length (in)	N/A	N/A	DWS Provided?	N/A
and the second		Surveyor Notes:		N/A	Landing Width (in)	N/A	N/A	DWS Contrast?	N/A

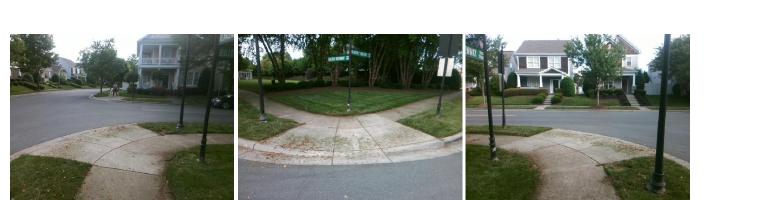
A Star	N/A		N/A	Landing Slope (%)	N/A	N/A	DWS Length (in)	N/A	
PROW/ADA: Not Found, R304.5.1				N/A	Landing X Slope (%)	N/A	N/A	DWS Full Width?	N/A
				N/A	Landing Curb? (Y/N)	N/A	N/A	DWS Offset (in)	N/A
				N/A	Shared Landing?	N/A			
				N/A	Gutter Ponding?	N/A	N/A	Gutter Slope (%)	N/A
				N/A	Gutter Lip Ht (in)	N/A	N/A	Gutter X Slope (%)	N/A
				N/A	Painted X Walk1?	No	N/A	Painted X Walk2?	No
					X Walk 1 Direction	To NE		X Walk 2 Direction	To NW
				N/A	X Walk 1 Width (in)	N/A	N/A	X Walk 2 Width (in)	N/A
Street 1 Name	BULLOCK GREENWAY BV	-			X Walk 1 Slope (%)	2.0		X Walk 2 Slope (%)	4.3
Stop Condition-Street 2	StopSign				X Walk 1 X Slope (%)	1.3		X Walk 2 X Slope (%)	1.1
Street 2 Name	BLAKENEY GREENS BV			N/A	Ramp inside XWalk1?	N/A	N/A	Ramp inside XWalk2?	N/A
Stop Condition-Street 1	None				Road Slope (%)	0.7	N/A	Clear Space?	N/A
					Road X Slope (%)	2.1	N/A	Clear Space to XWalk (in)	N/A
				N/A	Any Obstructions?	N/A	N/A	Storm Grate/Utility Hazard?	N/A

Total Cost: \$	3200.00		Obstruction Type			Storm Grate/Utility Type	
						N/A			N/A
