# Access Compliance Report

## Public Rights-of-Way

### (Curb Ramps)

Intersection ID: 29557	Main Street: CALABASSAS_LN	Cross Street: BIG_CREEK_CT	Location: SW
ADA ID: BFC2B7F588BB	Ramp Type: PerpDiag	Initial Pass/Fail: Fail	Overall Compliance: No
Severity Score: 21.25			
Codes/Mitigation Info/Possible Solution		Field Measurements/Component Compliance

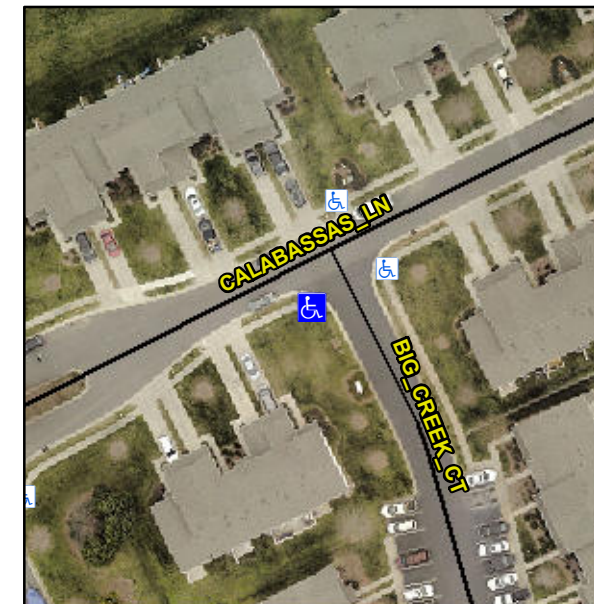
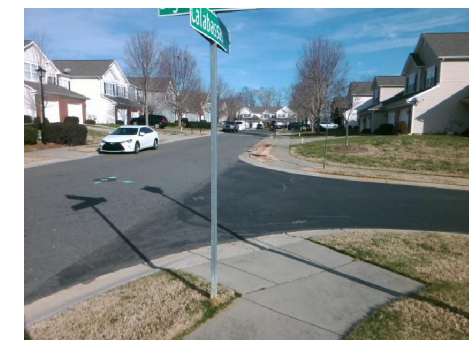
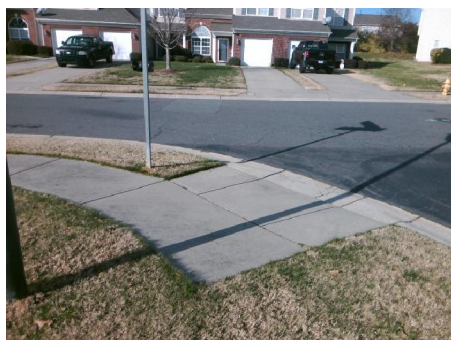
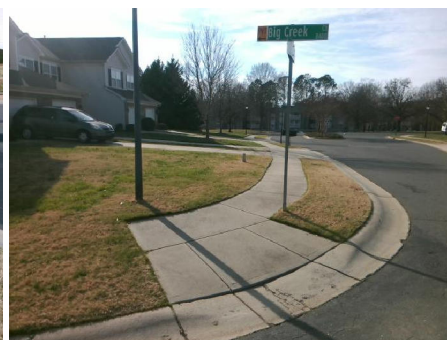
Compliance	Description	Data	Compliance	Description	Data
N/A	Ramp Length (in)	52.0	No	Ramp Slope (%)	9.4
No	Ramp Width (in)	38.0	Yes	Ramp XSlope (%)	1.5
N/A	Flare Type LT	N/A	N/A	Flare Type RT	N/A
N/A	Flare Slope LT (%)	N/A	N/A	Flare Slope RT (%)	N/A
N/A	Flare Traversable LT?	No	N/A	Flare Traversable RT?	No
N/A	Landing Length (in)	N/A	N/A	DWS Provided?	N/A
N/A	Landing Width (in)	N/A	N/A	DWS Contrast?	N/A
N/A	Landing Slope (%)	N/A	N/A	DWS Length (in)	N/A
N/A	Landing X Slope (%)	N/A	N/A	DWS Full Width?	N/A
N/A	Landing Curb? (Y/N)	N/A	N/A	DWS Offset (in)	N/A
N/A	Shared Landing?	N/A			
N/A	Gutter Ponding?	N/A	N/A	Gutter Slope (%)	N/A
N/A	Gutter Lip Ht (in)	N/A	N/A	Gutter X Slope (%)	N/A
N/A	Painted X Walk1?	No	N/A	Painted X Walk2?	No
	X Walk 1 Direction	To E		X Walk 2 Direction	To N
N/A	X Walk 1 Width (in)	N/A	N/A	X Walk 2 Width (in)	N/A
	X Walk 1 Slope (%)	1.3		X Walk 2 Slope (%)	5.4
	X Walk 1 X Slope (%)	5.9		X Walk 2 X Slope (%)	1.8

N/A	Ramp inside XWalk1?	N/A	N/A	Ramp inside XWalk2?	N/A
	Road Slope (%)	1.5	N/A	Clear Space?	N/A
	Road X Slope (%)	5.7	N/A	Clear Space to XWalk (in)	N/A
N/A	Any Obstructions?	N/A	N/A	Storm Grate/Utility Hazard?	N/A
	Obstruction Type			Storm Grate/Utility Type	
		N/A			N/A
		Yes		Surface Condition? (G/P)	Good

**Remove & Replace Curb Ramp With Two New Directional Ramps or Equivalent.**

**R304.5.1, R304.2.2**
