## Access Compliance Report Public Rights-of-Way (Curb Ramps)

Intersection ID: 27404 Main Street: BALLANTYNE\_COMMONS\_PY Cross Street: MEADOW\_RUN\_LN Location:

ADA ID: BFCBCCDCA071 Ramp Type: Perp Initial Pass/Fail: Fail Overall Compliance: No Severity Score: 8.75

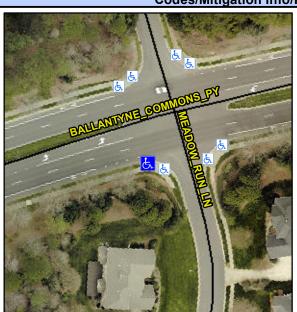
SW

Not Found, R304.5.1

Field Measurements/Component Compliance						
Compliance Description		Data	Comp	oliance Description	Data	
N/A	Ramp Length (in)	107.0	Yes	Ramp Slope (%)	6.5	
No	Ramp Width (in)	42.0	Yes	Ramp XSlope (%)	1.7	
N/A	Flare Type LT	N/A	N/A	Flare Type RT	N/A	
N/A	Flare Slope LT (%)	N/A	N/A	Flare Slope RT (%)	N/A	
N/A	Flare Traversable LT?	N/A	N/A	Flare Traversable RT?	N/A	
N/A	Landing Length (in)	N/A	N/A	DWS Provided?	N/A	
N/A	Landing Width (in)	N/A	N/A	DWS Contrast?	N/A	
N/A	Landing Slope (%)	N/A	N/A	DWS Length (in)	N/A	
N/A	Landing X Slope (%)	N/A	N/A	DWS Full Width?	N/A	
N/A	Landing Curb? (Y/N)	N/A	N/A	DWS Offset (in)	N/A	
N/A	Shared Landing?	N/A				
N/A	Gutter Ponding?	N/A	N/A	Gutter Slope (%)	N/A	
N/A	Gutter Lip Ht (in)	N/A	N/A	Gutter X Slope (%)	N/A	
N/A	Painted X Walk1?	No	N/A	Painted X Walk2?	N/A	
	X Walk 1 Direction	To N		X Walk 2 Direction	N/A	
N/A	X Walk 1 Width (in)	N/A	N/A	X Walk 2 Width (in)	N/A	
	X Walk 1 Slope (%)	3.6		X Walk 2 Slope (%)	N/A

Remove & Replace Entire Ramp.
