# Access Compliance Report

## Public Rights-of-Way

### (Curb Ramps)

Intersection ID: 26822	Main Street: CREEK_BEND_DR	Cross Street: RIDGEMORE_DR	Location: E
ADA ID: BFCE813A2055	Ramp Type: PerpDiag	Initial Pass/Fail: Fail	Overall Compliance: No
			Severity Score: 18.75

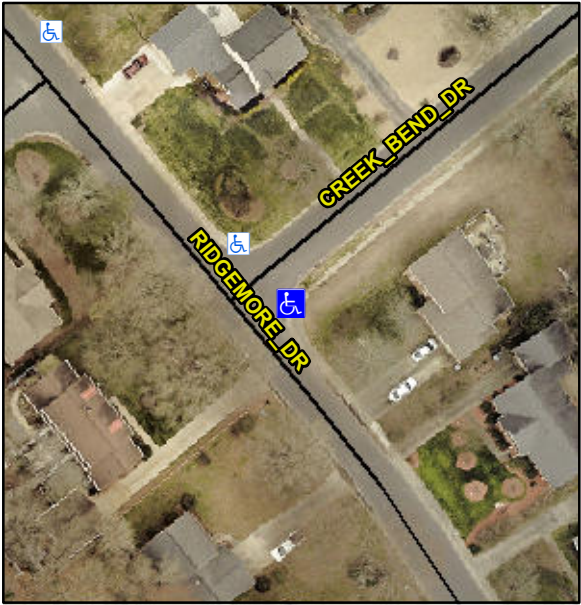
Possible Solutions:		<b>Compliance</b>	<b>Description</b>	<b>Data</b>
	<b>Remove &amp; Replace Curb Ramp With Two New Directional Ramps or Equivalent.</b>		<b>Yes</b>	Ramp Length (in)	<b>5.3</b>
			<b>No</b>	Ramp Width (in)	<b>3.1</b>
			<b>N/A</b>	Flare Type LT	<b>N/A</b>
			<b>N/A</b>	Flare Slope LT (%)	<b>N/A</b>
			<b>N/A</b>	Flare Traversable LT?	<b>N/A</b>
			<b>N/A</b>	Landing Length (in)	<b>N/A</b>
			<b>N/A</b>	Landing Width (in)	<b>N/A</b>
			<b>N/A</b>	Landing Slope (%)	<b>N/A</b>
			<b>N/A</b>	Landing X Slope (%)	<b>N/A</b>
<p>Surveyor Notes:</p> <p><b>N/A</b></p> <p>PROW/ADA:</p> <p><b>Not Found, R304.5.1, R304.5.3</b></p>			<b>N/A</b>	Flare Type RT	<b>N/A</b>
			<b>N/A</b>	Flare Slope RT (%)	<b>N/A</b>
			<b>N/A</b>	Flare Traversable RT?	<b>N/A</b>
			<b>N/A</b>	DWS Provided?	<b>N/A</b>
			<b>N/A</b>	DWS Contrast?	<b>N/A</b>

<b>N/A</b>	DWS Length (in)	<b>N/A</b>
			<b>N/A</b>	DWS Full Width?	<b>N/A</b>
			<b>N/A</b>	DWS Offset (in)	<b>N/A</b>
			<b>N/A</b>	Gutter Ponding?	<b>N/A</b>
			<b>N/A</b>	Gutter Lip Ht (in)	<b>N/A</b>
			<b>No</b>	Painted X Walk1?	<b>No</b>
				X Walk 1 Direction	<b>To NW</b>
			<b>N/A</b>	X Walk 1 Width (in)	<b>N/A</b>
			<b>0.9</b>	X Walk 1 Slope (%)	<b>1.4</b>
			<b>0.2</b>	X Walk 1 X Slope (%)	<b>0.4</b>
			<b>N/A</b>	Ramp inside XWalk1?	<b>N/A</b>
			<b>2.0</b>	Road Slope (%)	<b>N/A</b>
			<b>1.4</b>	Road X Slope (%)	<b>N/A</b>
			<b>N/A</b>	Any Obstructions?	<b>N/A</b>
				Obstruction Type	
Total Cost: \$ 3200.00			<b>N/A</b>	Storm Grate/Utility Hazard?	<b>N/A</b>
			<b>N/A</b>	Storm Grate/Utility Type	<b>N/A</b>
			<b>Yes</b>	Surface Condition? (G/P)	<b>Good</b>
