Access Compliance Report Public Rights-of-Way (Curb Ramps)

Intersection ID: 43922	Main Street: NORTH_COMMUNITY_HOUSE_& Street: JOHNSTON_RD								Location:	SW
ADA ID: BFD88FAF2324	Ramp Type: Perp			Initial	Initial Pass/Fail: Fail Overall Complian			nce: No Severity Score:		10
Codes/Mitigation Info/Possible Solution					Field Measurements/Component Compliance					
	1839	Possible Solutions:			Compliance Description		Data Compliance Description			Data
	11 1	Remove & Replace Entire Ra	eplace Entire Ramp.	р.	N/A	Ramp Length (in)	117.0	Yes	Ramp Slope (%)	6.9
	AND			•	No	Ramp Width (in)	38.0	No	Ramp XSlope (%)	2.7
	III IIII				N/A	Flare Type LT	N/A	N/A	Flare Type RT	N/A
NOPTH	1 mars				N/A	Flare Slope LT (%)	N/A	N/A	Flare Slope RT (%)	N/A
COMMUNITY -	1				N/A	Flare Traversable LT?	N/A	N/A	Flare Traversable RT?	N/A
TOUSE DO					N/A	Landing Length (in)	N/A	N/A	DWS Provided?	N/A
	H ×	Surveyor Notes:			N/A	Landing Width (in)	N/A	N/A	DWS Contrast?	N/A

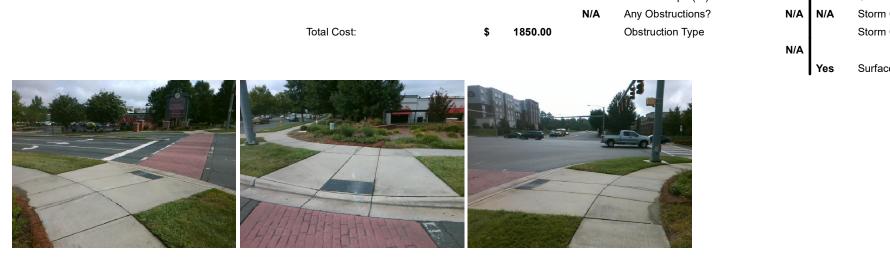
1.	N/A			N/A	Landing Slope (%)	N/A	N/A	DWS Length (in)	N/A
	1	5			N/A	Landing X Slope (%)	N/A	N/A	DWS Full Width?	N/A
E South Brook	3	2-12			N/A	Landing Curb? (Y/N)	N/A	N/A	DWS Offset (in)	N/A
Constant of the	MITTE C			N/A	Shared Landing?	N/A				
	THUR W	PROW/ADA:			N/A	Gutter Ponding?	N/A	N/A	Gutter Slope (%)	N/A
	Not Found, R3		N/A	Gutter Lip Ht (in)	N/A	N/A	Gutter X Slope (%)	N/A		
A Pro - AFRICA				N/A	Painted X Walk1?	Yes	N/A	Painted X Walk2?	N/A	
A STATE AND STATE AND IS				X Walk 1 Direction	To NE		X Walk 2 Direction	N/A		
THE AND A DECEMBER					N/A	X Walk 1 Width (in)	118.0	N/A	X Walk 2 Width (in)	N/A
Street 1 Name NORTH COMMUNITY HOUSE RD					X Walk 1 Slope (%)	0.5		X Walk 2 Slope (%)	N/A	
Stop Condition-Street 2	Signal					X Walk 1 X Slope (%)	2.5		X Walk 2 X Slope (%)	N/A
Street 2 Name	N/A				N/A	Ramp inside XWalk1?	Yes	N/A	Ramp inside XWalk2?	N/A
Stop Condition-Street 1	N/A					Road Slope (%)	N/A	N/A	Clear Space?	N/A

Road X Slope (%)	N/A	N/A	Clear Space to XWalk (in)	N/A
					N/A	Any Obstructions?	N/A	N/A	Storm Grate/Utility Hazard?	N/A
		Total Cost:	\$	1850.00		Obstruction Type			Storm Grate/Utility Type	
							N/A			N/A
								Yes	Surface Condition? (G/P)	Good
