Access Compliance Report

Public Rights-of-Way

(Curb Ramps)

| Intersection ID: 10022932 | Main Street: CEDAR_HILL_DR | Cross Street: N/A | Location: E |

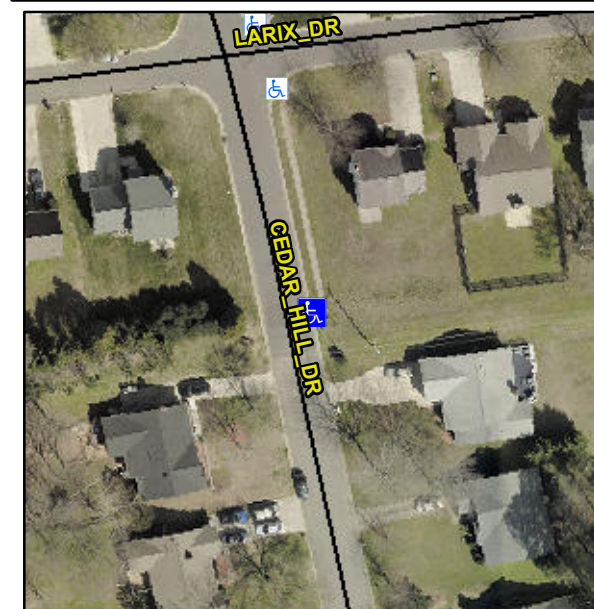
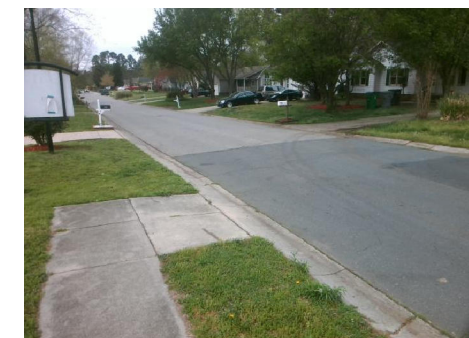
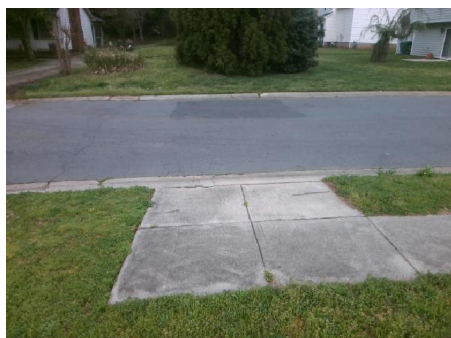
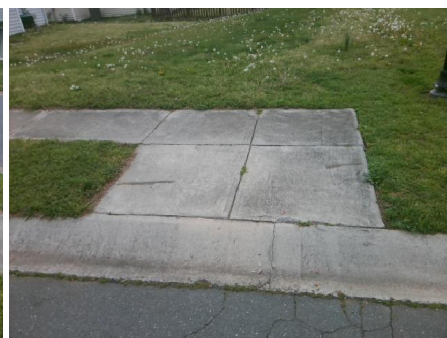
Not Found, R304.2.2, R304.5.3

| Compliance | Description | Data | Compliance | Description | Data |
|---|---|---|---|---|---|
| N/A | Ramp Length (in) | 48.0 | No | Ramp Slope (%) | 9.0 |
| Yes | Ramp Width (in) | 48.0 | No | Ramp XSlope (%) | 2.6 |

Possible Solutions:

Remove & Replace Entire Ramp.

Total Cost: \$ 1850.00
