# Access Compliance Report

## Public Rights-of-Way

### (Curb Ramps)

Intersection ID: 20542	Main Street: MORNING_MIST_LN	Cross Street: STEELECHASE_DR	Location: NW
ADA ID: BFDEE6723D44	Ramp Type: Perp	Initial Pass/Fail: Fail	Overall Compliance: No
		Severity Score: 12.5

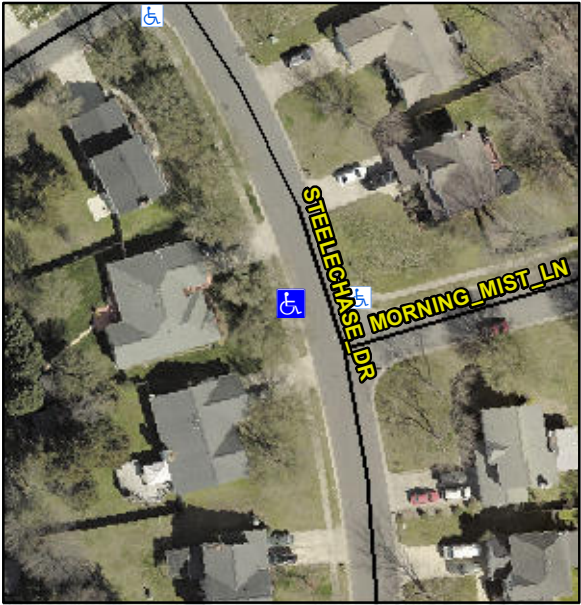
Possible Solutions:		<b>Compliance</b>	<b>Description</b>	<b>Data</b>
	<b>Remove &amp; Replace Entire Ramp.</b>		<b>Yes</b>	Ramp Length (in)	97.0
			<b>No</b>	Ramp Width (in)	48.0
			<b>N/A</b>	Flare Type LT	N/A
			<b>N/A</b>	Flare Slope LT (%)	N/A
			<b>N/A</b>	Flare Traversable LT?	N/A
			<b>N/A</b>	Landing Length (in)	N/A
			<b>N/A</b>	Landing Width (in)	N/A
			<b>N/A</b>	Landing Slope (%)	N/A
			<b>N/A</b>	Landing X Slope (%)	N/A
<p>Surveyor Notes:</p> <p><b>N/A</b></p> <p>PROW/ADA:</p> <p><b>Not Found, R304.5.3</b></p>			<b>N/A</b>	Flare Type RT	N/A
			<b>N/A</b>	Flare Slope RT (%)	N/A
			<b>N/A</b>	Flare Traversable RT?	N/A
			<b>N/A</b>	DWS Provided?	N/A
			<b>N/A</b>	DWS Contrast?	N/A
			<b>N/A</b>	DWS Length (in)	N/A
			<b>N/A</b>	DWS Full Width?	N/A
			<b>N/A</b>	DWS Offset (in)	N/A
			<b>N/A</b>	Shared Landing?	N/A

<b>N/A</b>	Gutter Ponding?	N/A
			<b>N/A</b>	Gutter Lip Ht (in)	N/A
			<b>No</b>	Painted X Walk1?	N/A
				X Walk 1 Direction	To E
			<b>N/A</b>	X Walk 1 Width (in)	N/A
			<b>4.4</b>	X Walk 1 Slope (%)	N/A
			<b>4.7</b>	X Walk 1 X Slope (%)	N/A
			<b>N/A</b>	Ramp inside XWalk1?	N/A
			<b>N/A</b>	Road Slope (%)	N/A
			<b>N/A</b>	Road X Slope (%)	N/A
			<b>N/A</b>	Any Obstructions?	N/A
				Obstruction Type	
			<b>N/A</b>		
			<b>N/A</b>		
			<b>N/A</b>		
			<b>N/A</b>		
			<b>N/A</b>		
			<b>N/A</b>		
			<b>N/A</b>		
			<b>N/A</b>		
			<b>N/A</b>		
Total Cost:		\$ 1850.00			
			<b>Yes</b>	Surface Condition? (G/P)	Good
