Access Compliance Report

Public Rights-of-Way

(Curb Ramps)

Intersection ID: 50344	Main Street: KELBURN_LN	Cross Street: FENWAY_DR	Location: SW
ADA ID: BFE499C1D77C	Ramp Type: Perp	Initial Pass/Fail: Pass	Overall Compliance: No
		Severity Score: 15

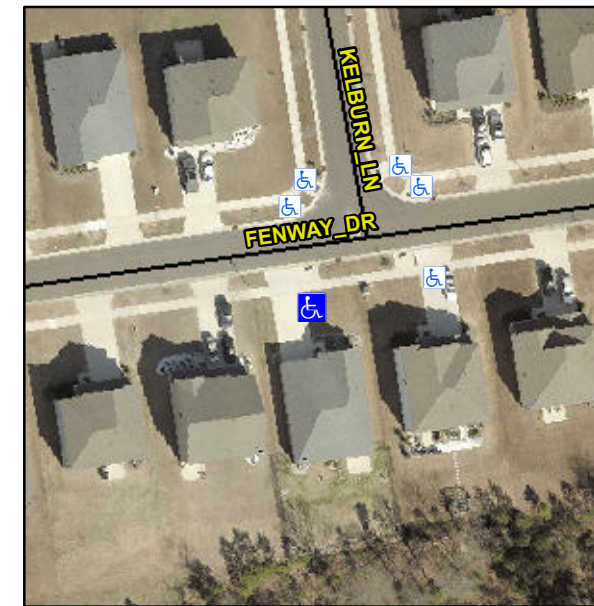
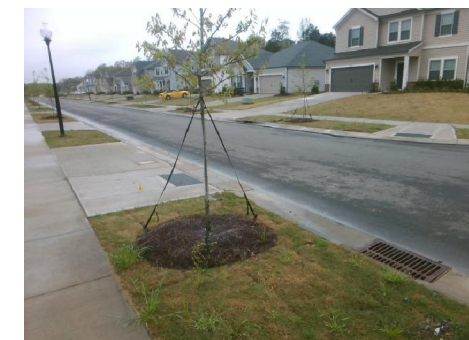
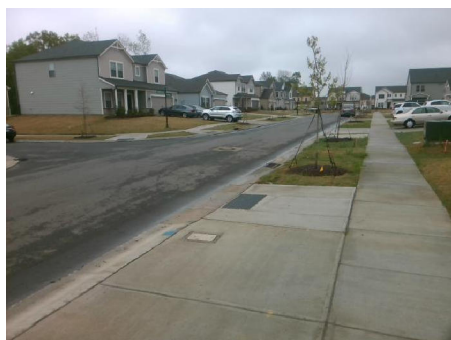
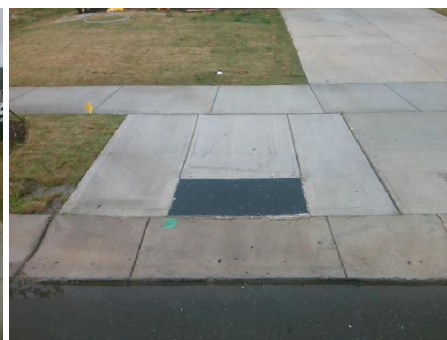
Compliance	Description	Data	Compliance	Description	Data
N/A	Ramp Length (in)	95.0	Yes	Ramp Slope (%)	6.4
Yes	Ramp Width (in)	48.0	Yes	Ramp XSlope (%)	0.0
N/A	Flare Type LT	Sloped	N/A	Flare Type RT	N/A
N/A	Flare Slope LT (%)	5.4	Yes	Flare Slope RT (%)	2.9
N/A	Flare Traversable LT?	Yes	N/A	Flare Traversable RT?	Yes
Yes	Landing Length (in)	60.0	Yes	DWS Provided?	Yes
Yes	Landing Width (in)	48.0	Yes	DWS Contrast?	Yes
Yes	Landing Slope (%)	1.6	Yes	DWS Length (in)	24.0
Yes	Landing X Slope (%)	1.2	Yes	DWS Full Width?	Yes
N/A	Landing Curb? (Y/N)	No	Yes	DWS Offset (in)	0.0
N/A	Shared Landing?	No			
No	Gutter Ponding?	Yes	Yes	Gutter Slope (%)	1.1
No	Gutter Lip Ht (in)	1.0	Yes	Gutter X Slope (%)	0.1
N/A	Painted X Walk1?	No	N/A	Painted X Walk2?	N/A
	X Walk 1 Direction	To N		X Walk 2 Direction	N/A
N/A	X Walk 1 Width (in)	N/A	N/A	X Walk 2 Width (in)	N/A
	X Walk 1 Slope (%)	5.0		X Walk 2 Slope (%)	N/A
	X Walk 1 X Slope (%)	0.5		X Walk 2 X Slope (%)	N/A

N/A	Ramp inside XWalk1?	N/A	N/A	Ramp inside XWalk2?	N/A
	Road Slope (%)	N/A	N/A	Clear Space?	Yes
	Road X Slope (%)	N/A	N/A	Clear Space to XWalk (in)	N/A
Yes	Any Obstructions?	No	Yes	Storm Grate/Utility Hazard?	No
	Obstruction Type			Storm Grate/Utility Type	
			N/A		N/A
			Yes	Surface Condition? (G/P)	Good

Possible Solutions:

Grind Gutter Lip.

R302.7, R302.7.2

Total Cost: \$ 200.00
