## Access Compliance Report Public Rights-of-Way (Curb Ramps)

Intersection ID: N/A Main Street: S\_DAVIDSON\_ST Cross Street: E\_STONEWALL\_ST Location: E

ADA ID: BFEE96D69613 Ramp Type: Perp Initial Pass/Fail: Fail Overall Compliance: No Severity Score: 10

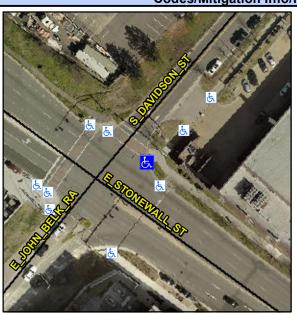
Yes N/A Ramp Length (in) 105.0 Ramp Slope (%) 7.9 47.0 No Ramp XSlope (%) No Ramp Width (in) 3.5 N/A N/A Flare Type LT N/A Flare Type RT N/A N/A N/A N/A Flare Slope RT (%) N/A Flare Slope LT (%) N/A Flare Traversable LT? N/A N/A Flare Traversable RT? N/A N/A N/A N/A **DWS Provided?** N/A Landing Length (in) N/A Landing Width (in) N/A N/A **DWS Contrast?** N/A N/A N/A N/A Landing Slope (%) DWS Length (in) N/A N/A Landing X Slope (%) N/A N/A DWS Full Width? N/A N/A Landing Curb? (Y/N) N/A N/A DWS Offset (in) N/A N/A N/A Shared Landing? N/A **Gutter Ponding?** N/A N/A Gutter Slope (%) N/A N/A Gutter Lip Ht (in) N/A N/A Gutter X Slope (%) N/A N/A Painted X Walk1? Yes N/A Painted X Walk2? N/A X Walk 1 Direction To NW X Walk 2 Direction N/A N/A 125.0 X Walk 1 Width (in) X Walk 2 Width (in) N/A X Walk 1 Slope (%) 2.5 X Walk 2 Slope (%) N/A X Walk 1 X Slope (%) 3.2 X Walk 2 X Slope (%) N/A N/A N/A Ramp inside XWalk2? Ramp inside XWalk1? Yes N/A Road Slope (%) N/A N/A Clear Space? N/A N/A Road X Slope (%) N/A Clear Space to XWalk (in) N/A N/A N/A Any Obstructions? N/A Storm Grate/Utility Hazard? N/A **Obstruction Type** Storm Grate/Utility Type N/A N/A Yes Surface Condition? (G/P) Good

Possible Solutions:

Remove & Replace Entire Ramp.
