# Access Compliance Report

## Public Rights-of-Way

| Intersection ID: 19209 | | Main Street: LIVINGSTON_DR | | Cross Street: SARDIS_RD | | Location: NE | | | |
| ADA ID: BFF1E8AE5BFB | | Ramp Type: Perp | | Initial Pass/Fail: Fail | | Overall Compliance: No | | Severity Score: 12.5 | |

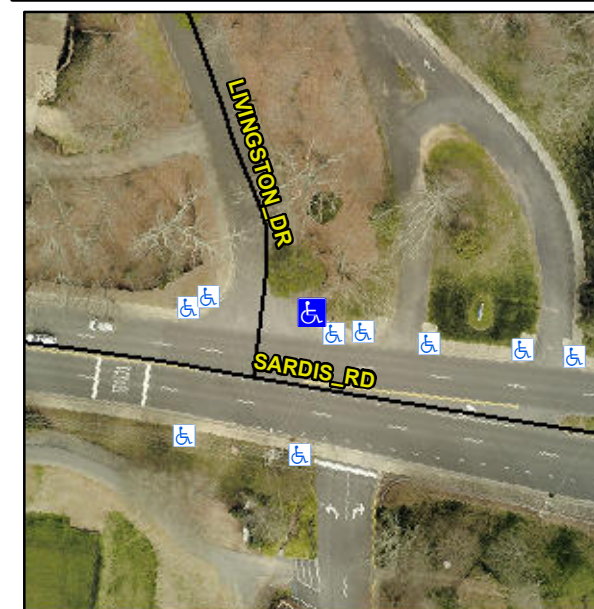
**Not Found, R304.2.2**

| Compliance | Description | Data | Compliance | Description | Data |
|---|---|---|---|---|---|
| N/A | Ramp Length (in) | 59.0 | No | Ramp Slope (%) | 10.1 |

**Remove & Replace Entire Ramp.**

Total Cost: \$ 1850.00
