# Access Compliance Report

## Public Rights-of-Way

### (Curb Ramps)

Intersection ID: 8591	Main Street: ORR_INDUSTRIAL_CT	Cross Street: ORR_RD	Location: SW
ADA ID: BFF9C38767AE	Ramp Type: PerpDiag	Initial Pass/Fail: Fail	Overall Compliance: No
Severity Score: 17.5			
Codes/Mitigation Info/Possible Solution		Field Measurements/Component Compliance

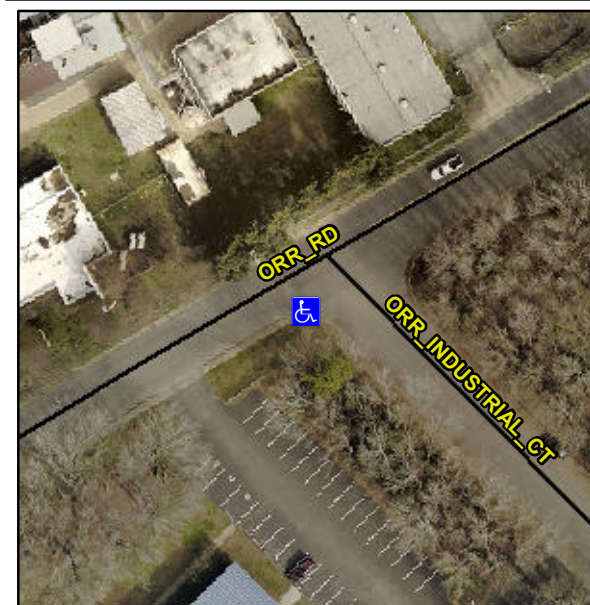
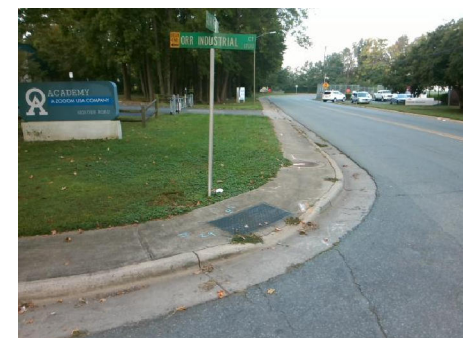
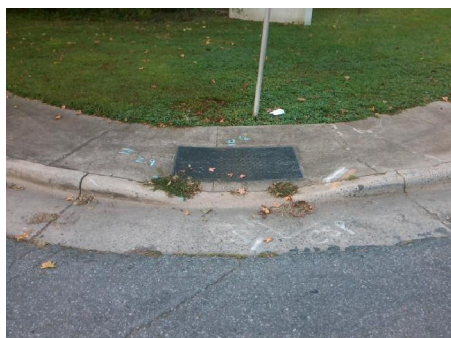
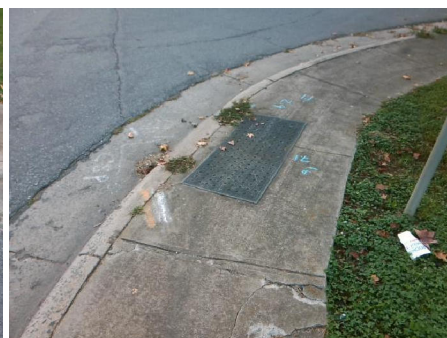
**Not Found, R304.5.1**

Compliance	Description	Data	Compliance	Description	Data
N/A	Ramp Length (in)	49.0	Yes	Ramp Slope (%)	7.1
No	Ramp Width (in)	32.0	Yes	Ramp XSlope (%)	1.6
N/A	Flare Type LT	N/A	N/A	Flare Type RT	N/A
N/A	Flare Slope LT (%)	N/A	N/A	Flare Slope RT (%)	N/A
N/A	Flare Traversable LT?	N/A	N/A	Flare Traversable RT?	N/A
N/A	Landing Length (in)	N/A	N/A	DWS Provided?	N/A
N/A	Landing Width (in)	N/A	N/A	DWS Contrast?	N/A
N/A	Landing Slope (%)	N/A	N/A	DWS Length (in)	N/A
N/A	Landing X Slope (%)	N/A	N/A	DWS Full Width?	N/A
N/A	Landing Curb? (Y/N)	N/A	N/A	DWS Offset (in)	N/A
N/A	Shared Landing?	N/A			
N/A	Gutter Ponding?	N/A	N/A	Gutter Slope (%)	N/A
N/A	Gutter Lip Ht (in)	N/A	N/A	Gutter X Slope (%)	N/A
N/A	Painted X Walk1?	No	N/A	Painted X Walk2?	No
	X Walk 1 Direction	To E		X Walk 2 Direction	To N
N/A	X Walk 1 Width (in)	N/A	N/A	X Walk 2 Width (in)	N/A
	X Walk 1 Slope (%)	N/A		X Walk 2 Slope (%)	N/A
	X Walk 1 X Slope (%)	N/A		X Walk 2 X Slope (%)	N/A

N/A	Ramp inside XWalk1?	N/A	N/A	Ramp inside XWalk2?	N/A
	Road Slope (%)	2.9	N/A	Clear Space?	N/A
	Road X Slope (%)	1.1	N/A	Clear Space to XWalk (in)	N/A
N/A	Any Obstructions?	N/A	N/A	Storm Grate/Utility Hazard?	N/A
	Obstruction Type			Storm Grate/Utility Type	
		N/A			N/A
			Yes	Surface Condition? (G/P)	Good

**Remove & Replace Curb Ramp With Two New Directional Ramps or Equivalent.**

Total Cost: \$ **3200.00**
