# Access Compliance Report

## Public Rights-of-Way

Intersection ID: 23907	Main Street: MCALPINE_FARM_RD	Cross Street: RIVER_RIDGE_RD	Location: SW
ADA ID: BFFF4C41A2FD	Ramp Type: PerpDiag	Initial Pass/Fail: Fail	Overall Compliance: No
Severity Score: 12.5			
Codes/Mitigation Info/Possible Solution		Field Measurements/Component Compliance

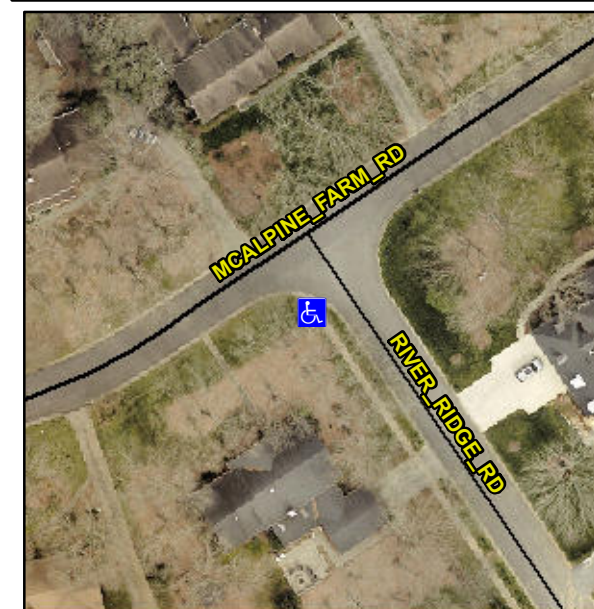
**Not Found, R304.5.3**

Compliance	Description	Data	Compliance	Description	Data
N/A	Ramp Length (in)	35.0	Yes	Ramp Slope (%)	8.3
Yes	Ramp Width (in)	48.0	No	Ramp XSlope (%)	6.2
N/A	Flare Type LT	N/A	N/A	Flare Type RT	N/A
N/A	Flare Slope LT (%)	N/A	N/A	Flare Slope RT (%)	N/A
N/A	Flare Traversable LT?	N/A	N/A	Flare Traversable RT?	N/A
N/A	Landing Length (in)	N/A	N/A	DWS Provided?	N/A
N/A	Landing Width (in)	N/A	N/A	DWS Contrast?	N/A
N/A	Landing Slope (%)	N/A	N/A	DWS Length (in)	N/A
N/A	Landing X Slope (%)	N/A	N/A	DWS Full Width?	N/A
N/A	Landing Curb? (Y/N)	N/A	N/A	DWS Offset (in)	N/A
N/A	Shared Landing?	N/A			
N/A	Gutter Ponding?	N/A	N/A	Gutter Slope (%)	N/A
N/A	Gutter Lip Ht (in)	N/A	N/A	Gutter X Slope (%)	N/A
N/A	Painted X Walk1?	No	N/A	Painted X Walk2?	No
	X Walk 1 Direction	To NE		X Walk 2 Direction	To NW
N/A	X Walk 1 Width (in)	N/A	N/A	X Walk 2 Width (in)	N/A
	X Walk 1 Slope (%)	2.6		X Walk 2 Slope (%)	3.3
	X Walk 1 X Slope (%)	4.0		X Walk 2 X Slope (%)	3.6

N/A	Ramp inside XWalk1?	N/A	N/A	Ramp inside XWalk2?	N/A
	Road Slope (%)	0.9	N/A	Clear Space?	N/A
	Road X Slope (%)	6.1	N/A	Clear Space to XWalk (in)	N/A
N/A	Any Obstructions?	N/A	N/A	Storm Grate/Utility Hazard?	N/A
	Obstruction Type			Storm Grate/Utility Type	
		N/A			N/A
		Yes		Surface Condition? (G/P)	Good

Possible Solutions:

**Remove & Replace Curb Ramp With Two New Directional Ramps or Equivalent.**
