# Access Compliance Report

## Public Rights-of-Way

### (Curb Ramps)

Intersection ID: 14311	Main Street: BERKELEY_AV	Cross Street: CARLTON_AV	Location: SW
ADA ID: C0000DD566A7	Ramp Type: Directional1	Initial Pass/Fail: Fail	Overall Compliance: No
		Severity Score: 25

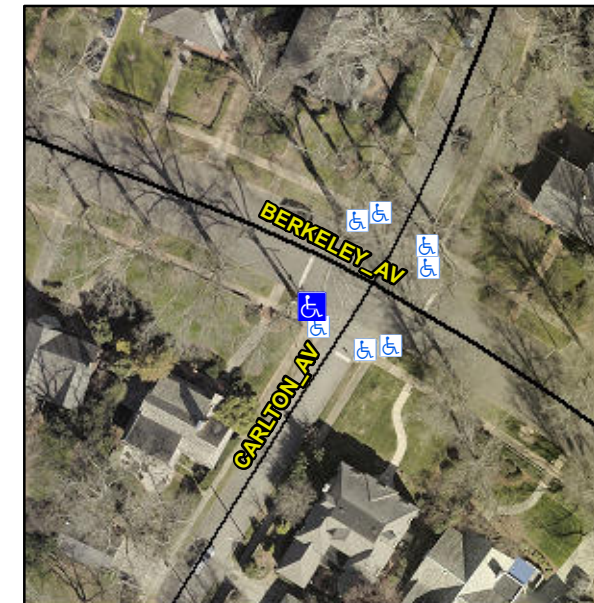
**R304.2.2, R304.5.3**

Compliance	Description	Data	Compliance	Description	Data
N/A	Ramp Length (in)	80.0	N/A	Grade Break?	N/A
Yes	Ramp Width (in)	63.0	N/A	Grade Break Slope (%)	0.0
No	Ramp Slope (%)	9.2	N/A	Grade Break XSlope (%)	0.0
No	Ramp XSlope (%)	5.3			
N/A	Flare Type LT	N/A	N/A	Flare Type RT	N/A
N/A	Flare Slope LT (%)	N/A	N/A	Flare Slope RT (%)	0.0
N/A	Flare Traversable LT?	N/A	N/A	Flare Traversable RT?	N/A
N/A	Landing Length (in)	0.0	N/A	DWS Provided?	N/A
N/A	Landing Width (in)	0.0	N/A	DWS Contrast?	N/A
N/A	Landing Slope (%)	0.0	N/A	DWS Length (in)	N/A
N/A	Landing X Slope (%)	0.0	N/A	DWS Full Width?	N/A
N/A	Landing Curb? (Y/N)	N/A	N/A	DWS Offset LT (in)	N/A
N/A	Shared Landing?	N/A	N/A	DWS Offset RT (in)	N/A
N/A	Gutter Ponding?	0.0	N/A	Gutter Slope (%)	N/A
N/A	Gutter Lip Ht (in)	1.0	N/A	Gutter X Slope (%)	N/A
N/A	Painted X Walk1?	No		Road Slope (%)	2.1
	X Walk 1 Direction	To NE		Road X Slope (%)	2.3
	X Walk 1 Width (in)	N/A		Clear Space?	N/A

X Walk 1 Slope (%)	2.1	N/A	Clear Space to XWalk (in)	N/A
	X Walk 1 X Slope (%)	2.3	N/A	Storm Grate/Utility Hazard?	N/A
N/A	Ramp inside XWalk1?	N/A		Storm Grate/Utility Type	
N/A	Any Obstructions?	N/A			N/A
	Obstruction Type		Yes	Surface Condition? (G/P)	Good
			N/A	Curb Slope (%)	14.3

**Remove & Replace Entire Ramp.**
