Access Compliance Report

Public Rights-of-Way

(Curb Ramps)

Intersection ID: 49130	Main Street: AUBURN_HILL_LN	Cross Street: WILTSHIRE_RIDGE_RD	Location: E
ADA ID: C01F6ED3BBF5	Ramp Type: Perp	Initial Pass/Fail: Fail	Overall Compliance: No
Severity Score: 12.5			
Codes/Mitigation Info/Possible Solution		Field Measurements/Component Compliance

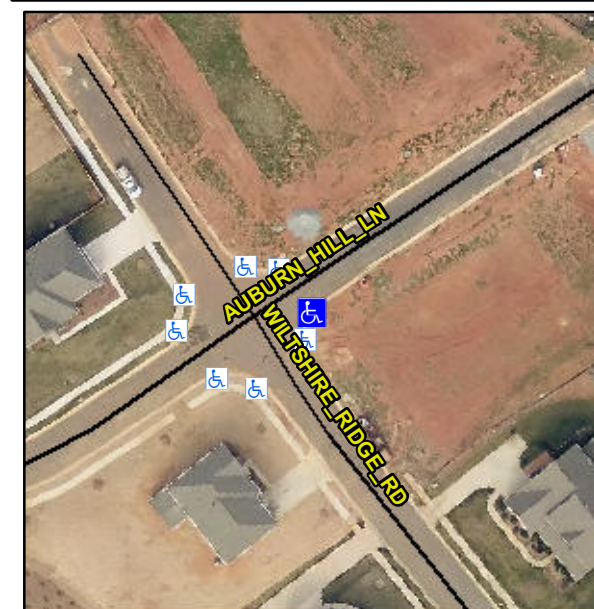
Not Found, R304.5.3

Compliance	Description	Data	Compliance	Description	Data
N/A	Ramp Length (in)	48.0	Yes	Ramp Slope (%)	5.1
Yes	Ramp Width (in)	48.0	No	Ramp XSlope (%)	5.5
N/A	Flare Type LT	N/A	N/A	Flare Type RT	N/A
N/A	Flare Slope LT (%)	N/A	N/A	Flare Slope RT (%)	N/A
N/A	Flare Traversable LT?	N/A	N/A	Flare Traversable RT?	N/A
N/A	Landing Length (in)	N/A	N/A	DWS Provided?	N/A
N/A	Landing Width (in)	N/A	N/A	DWS Contrast?	N/A
N/A	Landing Slope (%)	N/A	N/A	DWS Length (in)	N/A
N/A	Landing X Slope (%)	N/A	N/A	DWS Full Width?	N/A
N/A	Landing Curb? (Y/N)	N/A	N/A	DWS Offset (in)	N/A
N/A	Shared Landing?	N/A			
N/A	Gutter Ponding?	N/A	N/A	Gutter Slope (%)	N/A
N/A	Gutter Lip Ht (in)	N/A	N/A	Gutter X Slope (%)	N/A
N/A	Painted X Walk1?	No	N/A	Painted X Walk2?	N/A
	X Walk 1 Direction	To NW		X Walk 2 Direction	N/A
N/A	X Walk 1 Width (in)	N/A	N/A	X Walk 2 Width (in)	N/A
	X Walk 1 Slope (%)	8.4		X Walk 2 Slope (%)	N/A
	X Walk 1 X Slope (%)	7.8		X Walk 2 X Slope (%)	N/A

N/A	Ramp inside XWalk1?	N/A	N/A	Ramp inside XWalk2?	N/A
	Road Slope (%)	N/A	N/A	Clear Space?	N/A
	Road X Slope (%)	N/A	N/A	Clear Space to XWalk (in)	N/A
N/A	Any Obstructions?	N/A	N/A	Storm Grate/Utility Hazard?	N/A
	Obstruction Type			Storm Grate/Utility Type	
		N/A			N/A
		Yes		Surface Condition? (G/P)	Good

Remove & Replace Entire Ramp.

Total Cost: \$ 1850.00
