## Access Compliance Report Public Rights-of-Way (Curb Ramps)

Intersection ID: 25839 Main Street: CORPORATE\_CENTER\_DR Cross Street: JOHNSTON\_RD Location: NW

ADA ID: C026C9A030B1 Ramp Type: PerpDiag Initial Pass/Fail: Fail Overall Compliance: No Severity Score: 25

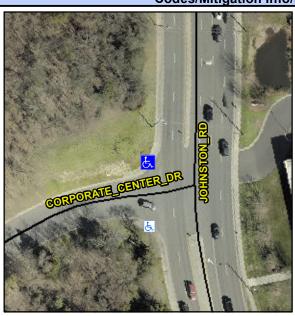
Not Found, R304.2.2, R304.5.3

Field Measurements/Component Compliance					
Compliance Description		Data	Comp	liance Description	Data
N/A	Ramp Length (in)	56.0	No	Ramp Slope (%)	8.4
Yes	Ramp Width (in)	48.0	No	Ramp XSlope (%)	5.7
N/A	Flare Type LT	N/A	N/A	Flare Type RT	N/A
N/A	Flare Slope LT (%)	N/A	N/A	Flare Slope RT (%)	N/A
N/A	Flare Traversable LT?	N/A	N/A	Flare Traversable RT?	N/A
N/A	Landing Length (in)	N/A	N/A	DWS Provided?	N/A
N/A	Landing Width (in)	N/A	N/A	DWS Contrast?	N/A
N/A	Landing Slope (%)	N/A	N/A	DWS Length (in)	N/A
N/A	Landing X Slope (%)	N/A	N/A	DWS Full Width?	N/A
N/A	Landing Curb? (Y/N)	N/A	N/A	DWS Offset (in)	N/A
N/A	Shared Landing?	N/A			
N/A	Gutter Ponding?	N/A	N/A	Gutter Slope (%)	N/A
N/A	Gutter Lip Ht (in)	N/A	N/A	Gutter X Slope (%)	N/A
N/A	Painted X Walk1?	No	N/A	Painted X Walk2?	No
	X Walk 1 Direction	To S		X Walk 2 Direction	То Е
N/A	X Walk 1 Width (in)	N/A	N/A	X Walk 2 Width (in)	N/A
	X Walk 1 Slope (%)	1.1		X Walk 2 Slope (%)	5.8

X Walk 1 X Slope (%)	5.0		X Walk 2 X Slope (%)	4.4
N/A	Ramp inside XWalk1?	N/A	N/A	Ramp inside XWalk2?	N/A
	Road Slope (%)	5.9	N/A	Clear Space?	N/A
	Road X Slope (%)	0.1	N/A	Clear Space to XWalk (in)	N/A
N/A	Any Obstructions?	N/A	N/A	Storm Grate/Utility Hazard?	N/A
	Obstruction Type			Storm Grate/Utility Type	
		N/A			N/A
			Yes	Surface Condition? (G/P)	Good

Remove & Replace Curb Ramp With Two New Directional Ramps or Equivalent.
