Intersection ID: 20286	Main Street: LONGDALE_DR	Cross Street: S_TRYON_ST	Location:	NW
ADA ID: C02C9E9E8D0E	Ramp Type: Perp	Initial Pass/Fail: Fail	Overall Compliance: No	Severity Score: 12.5

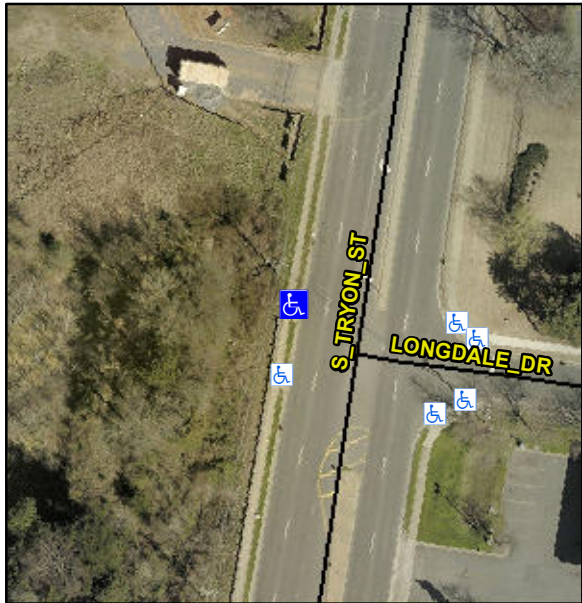
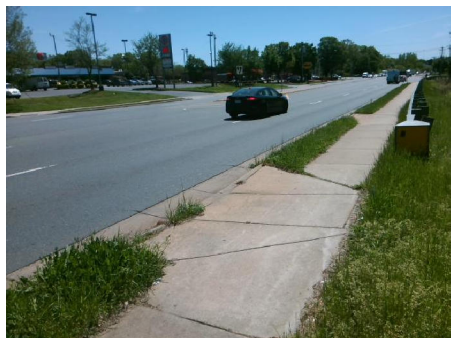
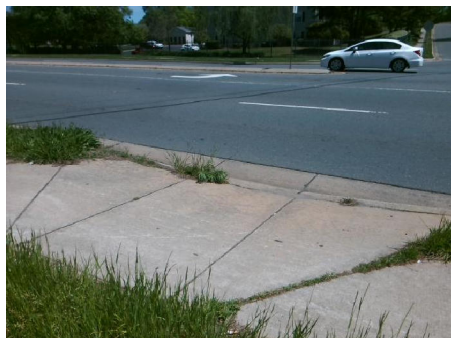
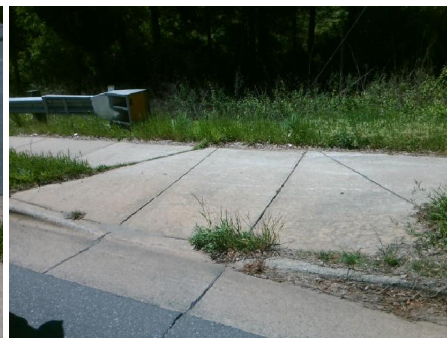
Possible Solutions:		Compliance	Description	Data	Compliance	Description	Data
	Remove & Replace Entire Ramp.		N/A	Ramp Length (in)	83.0	No	Ramp Slope (%)	10.2
			Yes	Ramp Width (in)	48.0	Yes	Ramp XSlope (%)	1.8
			N/A	Flare Type LT	N/A	N/A	Flare Type RT	N/A
			N/A	Flare Slope LT (%)	N/A	N/A	Flare Slope RT (%)	N/A
			N/A	Flare Traversable LT?	N/A	N/A	Flare Traversable RT?	N/A
			N/A	Landing Length (in)	N/A	N/A	DWS Provided?	N/A
	Surveyor Notes:		N/A	Landing Width (in)	N/A	N/A	DWS Contrast?	N/A
	N/A		N/A	Landing Slope (%)	N/A	N/A	DWS Length (in)	N/A
			N/A	Landing X Slope (%)	N/A	N/A	DWS Full Width?	N/A
			N/A	Landing Curb? (Y/N)	N/A	N/A	DWS Offset (in)	N/A
			N/A	Shared Landing?	N/A			
	PROW/ADA:		N/A	Gutter Ponding?	N/A	N/A	Gutter Slope (%)	N/A
	Not Found, R304.2.2		N/A	Gutter Lip Ht (in)	N/A	N/A	Gutter X Slope (%)	N/A

N/A	Painted X Walk1?	No	N/A	Painted X Walk2?	N/A
				X Walk 1 Direction	To E		X Walk 2 Direction	N/A
			N/A	X Walk 1 Width (in)	N/A	N/A	X Walk 2 Width (in)	N/A
				X Walk 1 Slope (%)	0.4		X Walk 2 Slope (%)	N/A
				X Walk 1 X Slope (%)	N/A		X Walk 2 X Slope (%)	N/A
			N/A	Ramp inside XWalk1?	N/A	N/A	Ramp inside XWalk2?	N/A
				Road Slope (%)	N/A	N/A	Clear Space?	N/A
				Road X Slope (%)	N/A	N/A	Clear Space to XWalk (in)	N/A
			N/A	Any Obstructions?	N/A	N/A	Storm Grate/Utility Hazard?	N/A
				Obstruction Type			Storm Grate/Utility Type	
	Total Cost:	\$ 1850.00			N/A			N/A
						Yes	Surface Condition? (G/P)	Good
