Access Compliance Report

Public Rights-of-Way

(Curb Ramps)

Intersection ID: N/A	Main Street: S BREVARD ST	Cross Street: E 3RD ST	Location: W
ADA ID: C031A2D700C4	Ramp Type: Perp	Initial Pass/Fail: Fail	Overall Compliance: No
Severity Score: 22.5			
Codes/Mitigation Info/Possible Solution		Field Measurements/Component Compliance

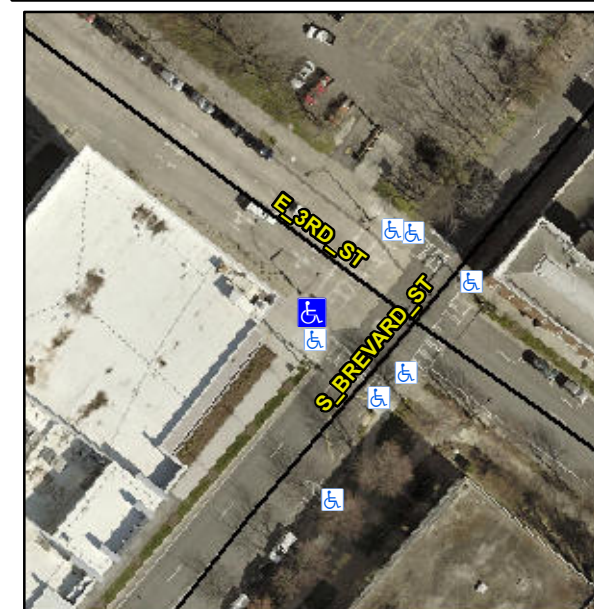
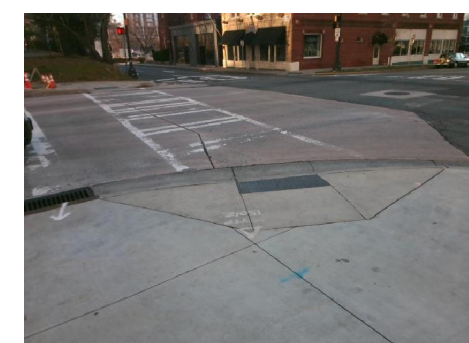
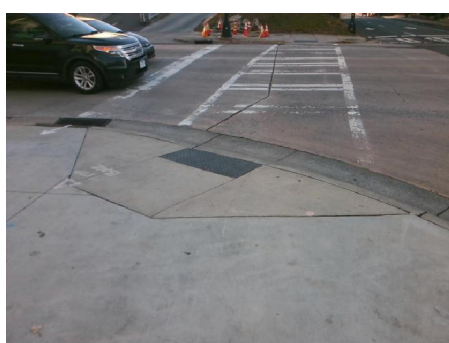
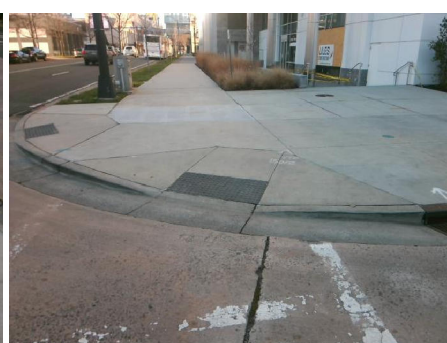
Not Found, R304.5.1, R304.2.2, R304.5.3

Compliance	Description	Data	Compliance	Description	Data
N/A	Ramp Length (in)	71.0	No	Ramp Slope (%)	10.5
No	Ramp Width (in)	45.0	No	Ramp XSlope (%)	2.8
N/A	Flare Type LT	N/A	N/A	Flare Type RT	N/A
N/A	Flare Slope LT (%)	N/A	N/A	Flare Slope RT (%)	N/A
N/A	Flare Traversable LT?	No	N/A	Flare Traversable RT?	No
N/A	Landing Length (in)	N/A	N/A	DWS Provided?	N/A
N/A	Landing Width (in)	N/A	N/A	DWS Contrast?	N/A
N/A	Landing Slope (%)	N/A	N/A	DWS Length (in)	N/A
N/A	Landing X Slope (%)	N/A	N/A	DWS Full Width?	N/A
N/A	Landing Curb? (Y/N)	N/A	N/A	DWS Offset (in)	N/A
N/A	Shared Landing?	N/A			
N/A	Gutter Ponding?	N/A	N/A	Gutter Slope (%)	N/A
N/A	Gutter Lip Ht (in)	N/A	N/A	Gutter X Slope (%)	N/A
N/A	Painted X Walk1?	Yes	N/A	Painted X Walk2?	N/A
	X Walk 1 Direction	To NE		X Walk 2 Direction	N/A
N/A	X Walk 1 Width (in)	102.0	N/A	X Walk 2 Width (in)	N/A
	X Walk 1 Slope (%)	1.2		X Walk 2 Slope (%)	N/A
	X Walk 1 X Slope (%)	0.7		X Walk 2 X Slope (%)	N/A

N/A	Ramp inside XWalk1?	Yes	N/A	Ramp inside XWalk2?	N/A
	Road Slope (%)	N/A	N/A	Clear Space?	N/A
	Road X Slope (%)	N/A	N/A	Clear Space to XWalk (in)	N/A
N/A	Any Obstructions?	N/A	N/A	Storm Grate/Utility Hazard?	N/A
	Obstruction Type			Storm Grate/Utility Type	
		N/A			N/A
		Yes		Surface Condition? (G/P)	Good

Remove & Replace Entire Ramp.
