Access Compliance Report

Public Rights-of-Way

(Curb Ramps)

Intersection ID: 23321	Main Street: BALLENTYNE_CT	Cross Street: GLENEAGLES_RD	Location: SE
ADA ID: C04BC2DD9C70	Ramp Type: PerpDiag	Initial Pass/Fail: Fail	Overall Compliance: No
		Severity Score: 37.5

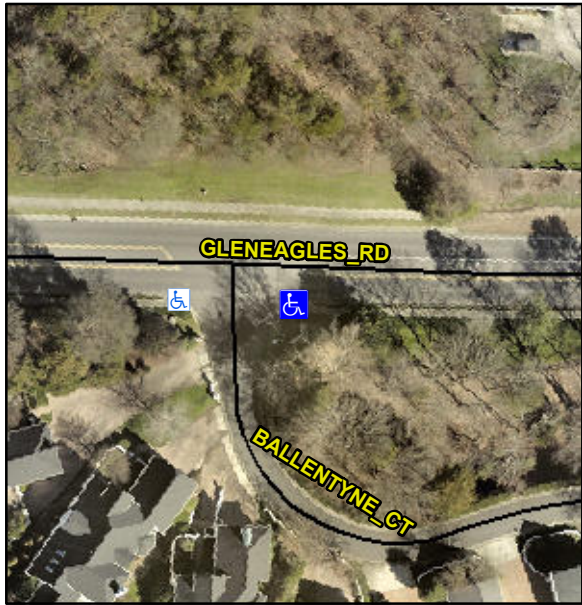
Possible Solutions:		Compliance	Description	Data	Compliance	Description	Data
	Remove & Replace Curb Ramp With Two New Directional Ramps or Equivalent.		N/A	Ramp Length (in)	31.0	No	Ramp Slope (%)	11.0
			Yes	Ramp Width (in)	48.0	No	Ramp XSlope (%)	10.4
			N/A	Flare Type LT	N/A	N/A	Flare Type RT	N/A
			N/A	Flare Slope LT (%)	N/A	N/A	Flare Slope RT (%)	N/A
			N/A	Flare Traversable LT?	N/A	N/A	Flare Traversable RT?	N/A
			N/A	Landing Length (in)	N/A	N/A	DWS Provided?	N/A
			N/A	Landing Width (in)	N/A	N/A	DWS Contrast?	N/A
			N/A	Landing Slope (%)	N/A	N/A	DWS Length (in)	N/A
			N/A	Landing X Slope (%)	N/A	N/A	DWS Full Width?	N/A
Surveyor Notes:	N/A		N/A	Landing Curb? (Y/N)	N/A	N/A	DWS Offset (in)	N/A
			N/A	Shared Landing?	N/A			
			N/A	Gutter Ponding?	N/A	N/A	Gutter Slope (%)	N/A
			N/A	Gutter Lip Ht (in)	N/A	N/A	Gutter X Slope (%)	N/A

N/A	Painted X Walk1?	No	N/A	Painted X Walk2?	No
				X Walk 1 Direction	To N		X Walk 2 Direction	To W
			N/A	X Walk 1 Width (in)	N/A	N/A	X Walk 2 Width (in)	N/A
				X Walk 1 Slope (%)	5.7		X Walk 2 Slope (%)	7.8
				X Walk 1 X Slope (%)	8.4		X Walk 2 X Slope (%)	2.3
			N/A	Ramp inside XWalk1?	N/A	N/A	Ramp inside XWalk2?	N/A
PROW/ADA:	Not Found, R304.2.2, R304.5.3			Road Slope (%)	7.6	N/A	Clear Space?	N/A
				Road X Slope (%)	9.2	N/A	Clear Space to XWalk (in)	N/A
			N/A	Any Obstructions?	N/A	N/A	Storm Grate/Utility Hazard?	N/A
				Obstruction Type			Storm Grate/Utility Type	
						N/A		N/A
						Yes	Surface Condition? (G/P)	Good
	Total Cost:		\$	3200.00
