Access Compliance Report

Public Rights-of-Way

(Curb Ramps)

Intersection ID: 11288	Main Street: DRUMMOND_AV	Cross Street: THE_PLAZA	Location:	N
ADA ID: C058D2D637C7	Ramp Type: Directional1	Initial Pass/Fail: Fail	Overall Compliance: No	Severity Score: 12.5
Codes/Mitigation Info/Possible Solution		Field Measurements/Component Compliance

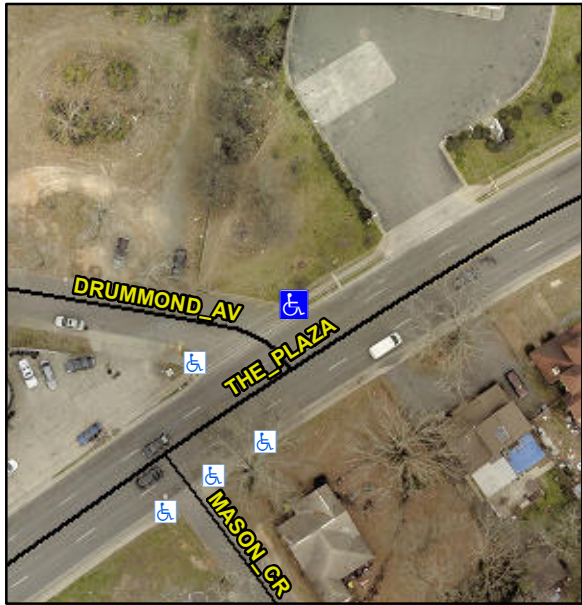
Compliance	Description	Data	Compliance	Description	Data
N/A	Ramp Length (in)	119.0	N/A	Grade Break?	N/A
Yes	Ramp Width (in)	48.0	N/A	Grade Break Slope (%)	0.0
No	Ramp Slope (%)	8.5	N/A	Grade Break XSlope (%)	0.0
Yes	Ramp XSlope (%)	1.6			
N/A	Flare Type LT	N/A	N/A	Flare Type RT	N/A
N/A	Flare Slope LT (%)	N/A	N/A	Flare Slope RT (%)	0.0
N/A	Flare Traversable LT?	N/A	N/A	Flare Traversable RT?	N/A
N/A	Landing Length (in)	0.0	N/A	DWS Provided?	N/A
N/A	Landing Width (in)	0.0	N/A	DWS Contrast?	N/A
N/A	Landing Slope (%)	0.0	N/A	DWS Length (in)	N/A
N/A	Landing X Slope (%)	0.0	N/A	DWS Full Width?	N/A
N/A	Landing Curb? (Y/N)	N/A	N/A	DWS Offset LT (in)	N/A
N/A	Shared Landing?	N/A	N/A	DWS Offset RT (in)	N/A
N/A	Gutter Ponding?	0.0	N/A	Gutter Slope (%)	N/A
N/A	Gutter Lip Ht (in)	0.5	N/A	Gutter X Slope (%)	N/A
N/A	Painted X Walk1?	No		Road Slope (%)	0.7
	X Walk 1 Direction	To SW		Road X Slope (%)	8.0
	X Walk 1 Width (in)	N/A		Clear Space?	N/A

X Walk 1 Slope (%)	0.7	N/A	Clear Space to XWalk (in)	N/A
	X Walk 1 X Slope (%)	8.0	N/A	Storm Grate/Utility Hazard?	N/A
N/A	Ramp inside XWalk1?	N/A		Storm Grate/Utility Type	
N/A	Any Obstructions?	N/A			N/A
	Obstruction Type		Yes	Surface Condition? (G/P)	Good
			N/A	Curb Slope (%)	0.5

Possible Solutions:

Remove & Replace Entire Ramp.

PROW/ADA:

R304.2.2
