Access Compliance Report Public Rights-of-Way (Curb Ramps)

Intersection ID: 29381 Main Street: GLENDYNE_DR Cross Street: PLEASANT_DALE_DR Location: SW

ADA ID: C067BE9302B0 Ramp Type: PerpDiag Initial Pass/Fail: Fail Overall Compliance: No Severity Score: 8.75

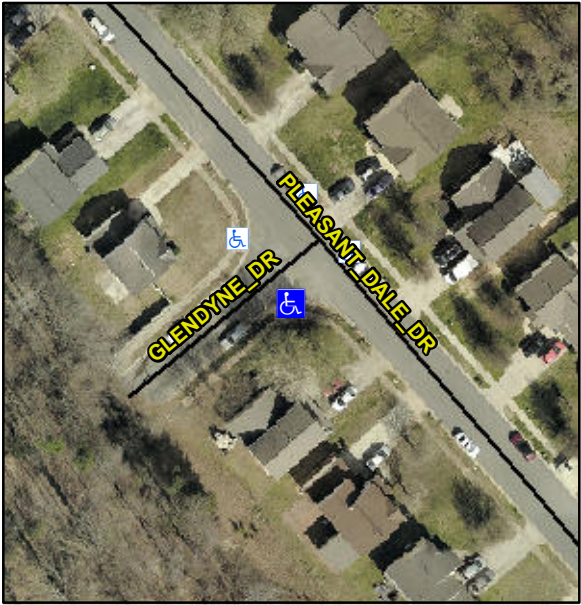
PROW/ADA:
R304.5.1

Compliance	Description	Data	Compliance	Description	Data
N/A	Ramp Length (in)	46.5	Yes	Ramp Slope (%)	7.3
No	Ramp Width (in)	39.0	Yes	Ramp XSlope (%)	0.1
N/A	Flare Type LT	N/A	N/A	Flare Type RT	N/A
N/A	Flare Slope LT (%)	N/A	N/A	Flare Slope RT (%)	N/A
N/A	Flare Traversable LT?	N/A	N/A	Flare Traversable RT?	N/A
N/A	Landing Length (in)	N/A	N/A	DWS Provided?	N/A
N/A	Landing Width (in)	N/A	N/A	DWS Contrast?	N/A
N/A	Landing Slope (%)	N/A	N/A	DWS Length (in)	N/A
N/A	Landing X Slope (%)	N/A	N/A	DWS Full Width?	N/A
N/A	Landing Curb? (Y/N)	N/A	N/A	DWS Offset (in)	N/A
N/A	Shared Landing?	N/A			
N/A	Gutter Ponding?	N/A	N/A	Gutter Slope (%)	N/A
N/A	Gutter Lip Ht (in)	N/A	N/A	Gutter X Slope (%)	N/A
N/A	Painted X Walk1?	No	N/A	Painted X Walk2?	No
	X Walk 1 Direction	To NE		X Walk 2 Direction	To NW
N/A	X Walk 1 Width (in)	N/A	N/A	X Walk 2 Width (in)	N/A
	X Walk 1 Slope (%)	0.0		X Walk 2 Slope (%)	0.4
	X Walk 1 X Slope (%)	1.7		X Walk 2 X Slope (%)	2.5

N/A	Ramp inside XWalk1?	N/A	N/A	Ramp inside XWalk2?	N/A
	Road Slope (%)	2.5	N/A	Clear Space?	N/A
	Road X Slope (%)	0.9	N/A	Clear Space to XWalk (in)	N/A
N/A	Any Obstructions?	N/A	N/A	Storm Grate/Utility Hazard?	N/A
	Obstruction Type			Storm Grate/Utility Type	
		N/A			N/A
			Yes	Surface Condition? (G/P)	Good

Possible Solutions:
Remove & Replace Curb Ramp With Two New Directional Ramps or Equivalent.
