| Intersection ID: 20969 | Main Street: OLD_REID_RD | Cross Street: PARK_RD | Location: | NE |
| ADA ID: C069B2F537E0 | Ramp Type: PerpDiag | Initial Pass/Fail: Pass | Overall Compliance: No | Severity Score: 27.75 |

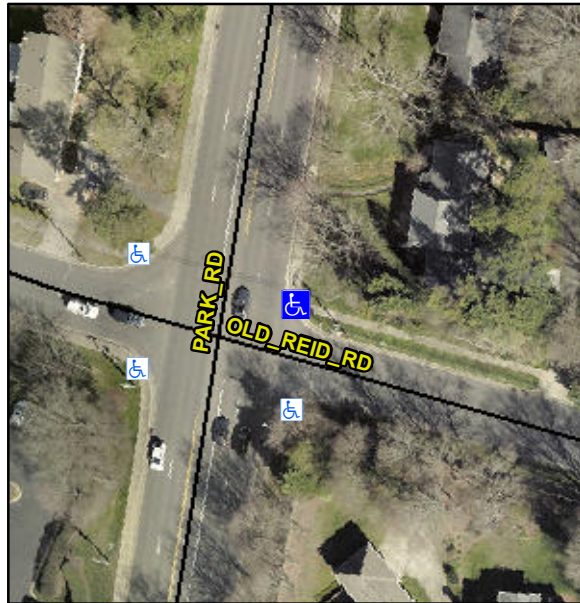
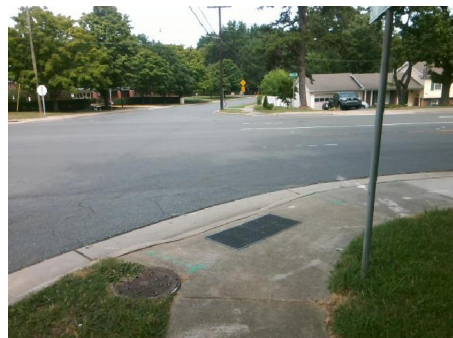
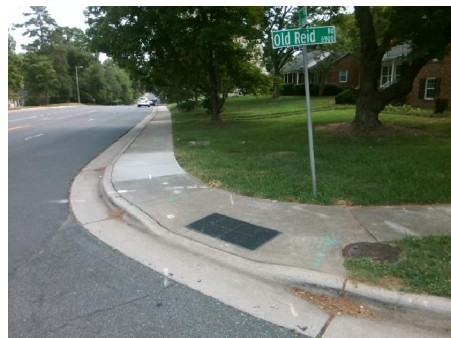
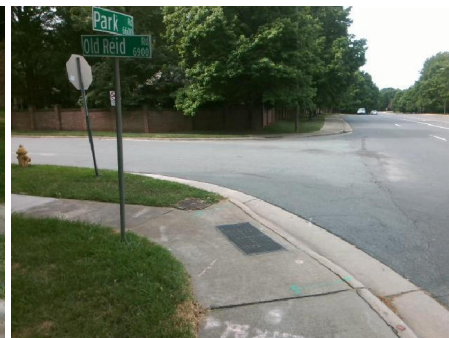
**Not Found, R304.5.3, R304.2.1,  
R304.2.2-Perp, R304.3.2-Para,  
R304.2.3, R305.2, R302.7.2, R304.5.4**

| Compliance | Description | Data | Compliance | Description | Data |
|---|---|---|---|---|---|
| Yes | Ramp Width (in) | 48.0 | No | Ramp XSlope (%) | 3.8 |
| N/A | Flare Slope LT (%) | 6.2 | No | Flare Slope RT (%) | 13.6 |
| No | Landing Length (in) | N/A | Yes | DWS Provided? | Yes |
| N/A | Landing Curb? (Y/N) | No | No | DWS Offset (in) | 8.0 |
| Yes | Gutter Ponding? | No | No | Gutter Slope (%) | 5.4 |
| No | Gutter Lip Ht (in) | 0.5 | No | Gutter X Slope (%) | 3.8 |

**Remove & Replace Curb Ramp With Two New Directional Ramps or Equivalent. Remove & Replace Gutter.**
