# Access Compliance Report

## Public Rights-of-Way

### (Curb Ramps)

| Intersection ID: 2755 | Main Street: BELL'S MILL_DR | Cross Street: RIDGEFIELD_DR | Location: W |

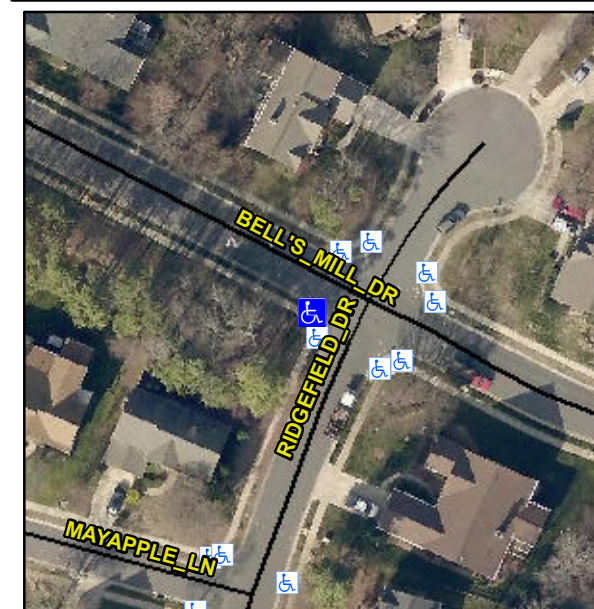
| ADA ID: C07F88E16E13 | Ramp Type: Perp | Initial Pass/Fail: Fail | Overall Compliance: No |
| Severity Score: 18.75 | | | |

**N/A**

**R304.5.1**

| Compliance | Description | Data | Compliance | Description | Data |
|---|---|---|---|---|---|
| N/A | Ramp Length (in) | 52.0 | Yes | Ramp Slope (%) | 7.6 |
| No | Ramp Width (in) | 35.0 | Yes | Ramp XSlope (%) | 3.0 |

**Remove & Replace Entire Ramp.**

**\$ 1850.00**
