Access Compliance Report

Public Rights-of-Way

(Curb Ramps)

Intersection ID: N/A	Main Street: REMOUNT_RD	Cross Street: REMUS_RD	Location: S
ADA ID: C081ABF594C8	Ramp Type: Perp	Initial Pass/Fail: Fail	Overall Compliance: No
Codes/Mitigation Info/Possible Solution		Field Measurements/Component Compliance	
Severity Score: 21.25

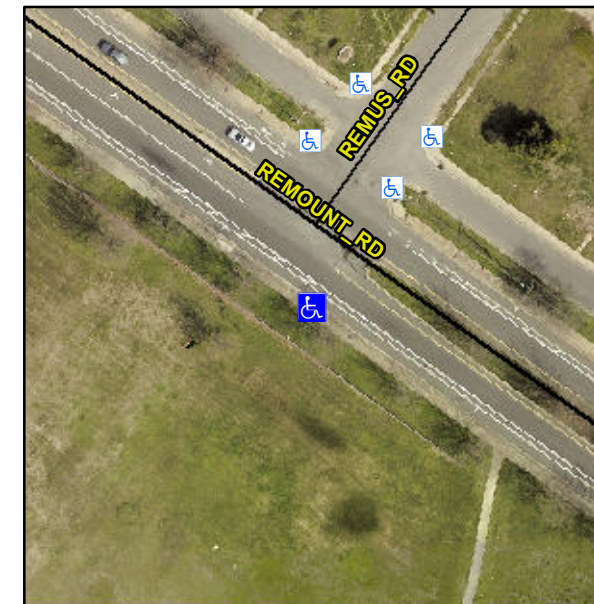
Not Found, R304.5.1, R304.2.2

Compliance	Description	Data	Compliance	Description	Data
N/A	Ramp Length (in)	60.0	No	Ramp Slope (%)	8.6
No	Ramp Width (in)	46.5	Yes	Ramp XSlope (%)	0.1
N/A	Flare Type LT	N/A	N/A	Flare Type RT	N/A
N/A	Flare Slope LT (%)	N/A	N/A	Flare Slope RT (%)	N/A
N/A	Flare Traversable LT?	N/A	N/A	Flare Traversable RT?	N/A
N/A	Landing Length (in)	N/A	N/A	DWS Provided?	N/A
N/A	Landing Width (in)	N/A	N/A	DWS Contrast?	N/A
N/A	Landing Slope (%)	N/A	N/A	DWS Length (in)	N/A
N/A	Landing X Slope (%)	N/A	N/A	DWS Full Width?	N/A
N/A	Landing Curb? (Y/N)	N/A	N/A	DWS Offset (in)	N/A
N/A	Shared Landing?	N/A			
N/A	Gutter Ponding?	N/A	N/A	Gutter Slope (%)	N/A
N/A	Gutter Lip Ht (in)	N/A	N/A	Gutter X Slope (%)	N/A
N/A	Painted X Walk1?	No	N/A	Painted X Walk2?	N/A
	X Walk 1 Direction	To NE		X Walk 2 Direction	N/A
N/A	X Walk 1 Width (in)	N/A	N/A	X Walk 2 Width (in)	N/A
	X Walk 1 Slope (%)	2.6		X Walk 2 Slope (%)	N/A
	X Walk 1 X Slope (%)	0.2		X Walk 2 X Slope (%)	N/A

N/A	Ramp inside XWalk1?	N/A	N/A	Ramp inside XWalk2?	N/A
	Road Slope (%)	N/A	N/A	Clear Space?	N/A
	Road X Slope (%)	N/A	N/A	Clear Space to XWalk (in)	N/A
N/A	Any Obstructions?	N/A	N/A	Storm Grate/Utility Hazard?	N/A
	Obstruction Type			Storm Grate/Utility Type	
		N/A			N/A
			Yes	Surface Condition? (G/P)	Good

Possible Solutions:

Remove & Replace Entire Ramp.
