# Access Compliance Report

## Public Rights-of-Way

### (Curb Ramps)

Intersection ID: 10020349	Main Street: BALLANTYNE COMMONS PY	Cross Street: N/A	Location: SE
ADA ID: C08AE0F79F82	Ramp Type: Perp	Initial Pass/Fail: Fail	Overall Compliance: No
		Severity Score: 60	
Codes/Mitigation Info/Possible Solution		Field Measurements/Component Compliance

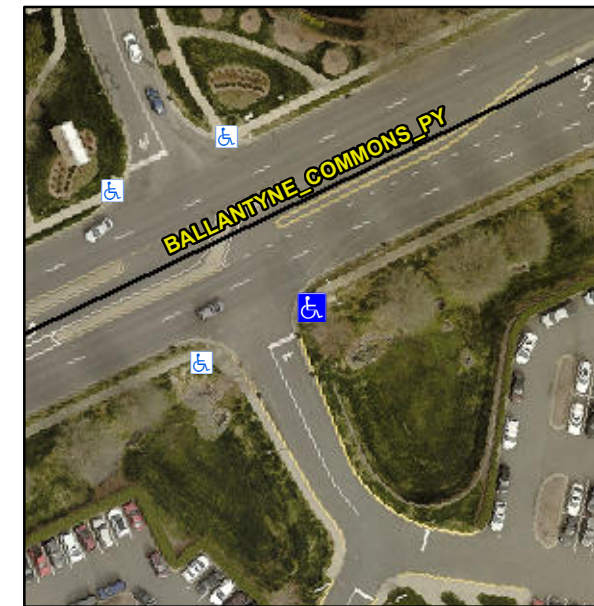
**Not Found, R304.5.1, R304.5.3**

Compliance	Description	Data	Compliance	Description	Data
N/A	Ramp Length (in)	105.0	Yes	Ramp Slope (%)	5.1
No	Ramp Width (in)	29.5	No	Ramp XSlope (%)	9.7
N/A	Flare Type LT	N/A	N/A	Flare Type RT	N/A
N/A	Flare Slope LT (%)	N/A	N/A	Flare Slope RT (%)	N/A
N/A	Flare Traversable LT?	N/A	N/A	Flare Traversable RT?	N/A
N/A	Landing Length (in)	N/A	N/A	DWS Provided?	N/A
N/A	Landing Width (in)	N/A	N/A	DWS Contrast?	N/A
N/A	Landing Slope (%)	N/A	N/A	DWS Length (in)	N/A
N/A	Landing X Slope (%)	N/A	N/A	DWS Full Width?	N/A
N/A	Landing Curb? (Y/N)	N/A	N/A	DWS Offset (in)	N/A
N/A	Shared Landing?	N/A			
N/A	Gutter Ponding?	N/A	N/A	Gutter Slope (%)	N/A
N/A	Gutter Lip Ht (in)	N/A	N/A	Gutter X Slope (%)	N/A
N/A	Painted X Walk1?	No	N/A	Painted X Walk2?	N/A
	X Walk 1 Direction	To W		X Walk 2 Direction	N/A
N/A	X Walk 1 Width (in)	N/A	N/A	X Walk 2 Width (in)	N/A
	X Walk 1 Slope (%)	4.3		X Walk 2 Slope (%)	N/A
	X Walk 1 X Slope (%)	5.5		X Walk 2 X Slope (%)	N/A

N/A	Ramp inside XWalk1?	N/A	N/A	Ramp inside XWalk2?	N/A
	Road Slope (%)	N/A	N/A	Clear Space?	N/A
	Road X Slope (%)	N/A	N/A	Clear Space to XWalk (in)	N/A
N/A	Any Obstructions?	N/A	N/A	Storm Grate/Utility Hazard?	N/A
	Obstruction Type			Storm Grate/Utility Type	
		N/A			N/A
			Yes	Surface Condition? (G/P)	Good

**Remove & Replace Entire Ramp.**
