Intersection ID: 13369	Main Street: WEST_BV	Cross Street: N_I-77_RAMP	Location:	NE
ADA ID: C094C3520C3F	Ramp Type: Perp	Initial Pass/Fail: Fail	Overall Compliance: No	Severity Score: 21.25

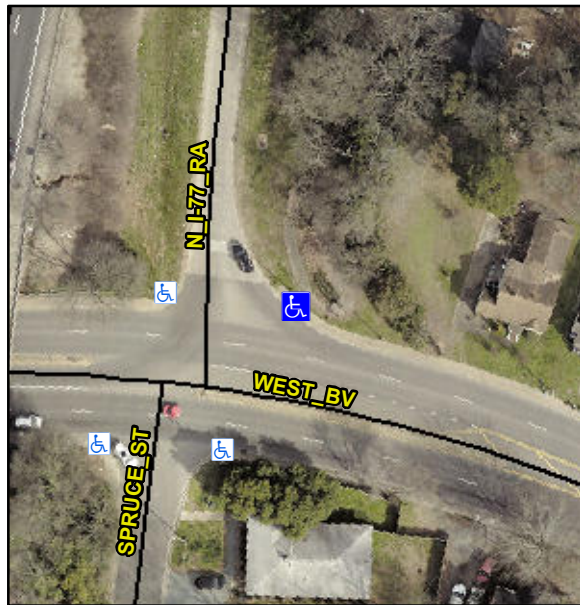
Not Found, R304.5.1, R304.2.2

Possible Solutions:			Compliance	Description	Data	Compliance	Description	Data
Remove & Replace Entire Ramp.	N/A	Ramp Length (in)	48.0	No	Ramp Slope (%)	8.4		
	No	Ramp Width (in)	45.0	Yes	Ramp XSlope (%)	0.5		
	N/A	Flare Type LT	N/A	N/A	Flare Type RT	N/A		
	N/A	Flare Slope LT (%)	N/A	N/A	Flare Slope RT (%)	N/A		
	N/A	Flare Traversable LT?	N/A	N/A	Flare Traversable RT?	N/A		
	N/A	Landing Length (in)	N/A	N/A	DWS Provided?	N/A		
	N/A	Landing Width (in)	N/A	N/A	DWS Contrast?	N/A		
	N/A	Landing Slope (%)	N/A	N/A	DWS Length (in)	N/A		
	N/A	Landing X Slope (%)	N/A	N/A	DWS Full Width?	N/A		
	N/A	Landing Curb? (Y/N)	N/A	N/A	DWS Offset (in)	N/A		
Surveyor Notes: N/A	N/A	Shared Landing?	N/A					
	N/A	Gutter Ponding?	N/A	N/A	Gutter Slope (%)	N/A		
	N/A	Gutter Lip Ht (in)	N/A	N/A	Gutter X Slope (%)	N/A		
	N/A	Painted X Walk1?	No	N/A	Painted X Walk2?	N/A		
		X Walk 1 Direction	To W		X Walk 2 Direction	N/A		
	N/A	X Walk 1 Width (in)	N/A	N/A	X Walk 2 Width (in)	N/A

X Walk 1 Slope (%)	0.1		X Walk 2 Slope (%)	N/A		
		X Walk 1 X Slope (%)	0.4		X Walk 2 X Slope (%)	N/A		
	N/A	Ramp inside XWalk1?	N/A	N/A	Ramp inside XWalk2?	N/A		
		Road Slope (%)	N/A	N/A	Clear Space?	N/A		
PROW/ADA: Not Found, R304.5.1, R304.2.2		Road X Slope (%)	N/A	N/A	Clear Space to XWalk (in)	N/A		
	N/A	Any Obstructions?	N/A	N/A	Storm Grate/Utility Hazard?	N/A		
		Obstruction Type			Storm Grate/Utility Type			
			N/A			N/A		
				Yes	Surface Condition? (G/P)	Good		
Total Cost:	\$	1850.00

Remove & Replace Entire Ramp.
