Access Compliance Report

Public Rights-of-Way

(Curb Ramps)

Intersection ID: N/A	Main Street: SHARON_AMITY_RD	Cross Street: N/A	Location: SE
ADA ID: C09AB6D2CAE3	Ramp Type: PerpDiag	Initial Pass/Fail: Fail	Overall Compliance: No
Codes/Mitigation Info/Possible Solution		Field Measurements/Component Compliance

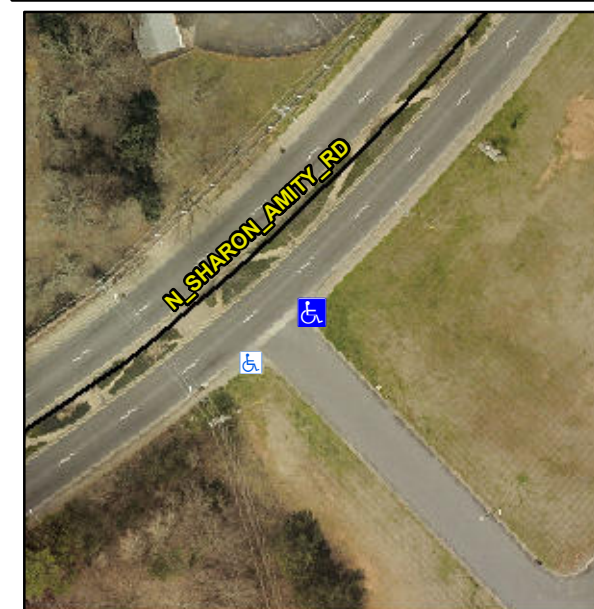
Not Found, R304.5.1, R304.2.2

Compliance	Description	Data	Compliance	Description	Data
N/A	Ramp Length (in)	61.0	No	Ramp Slope (%)	13.7
No	Ramp Width (in)	38.0	Yes	Ramp XSlope (%)	2.6
N/A	Flare Type LT	N/A	N/A	Flare Type RT	N/A
N/A	Flare Slope LT (%)	N/A	N/A	Flare Slope RT (%)	N/A
N/A	Flare Traversable LT?	N/A	N/A	Flare Traversable RT?	N/A
N/A	Landing Length (in)	N/A	N/A	DWS Provided?	N/A
N/A	Landing Width (in)	N/A	N/A	DWS Contrast?	N/A
N/A	Landing Slope (%)	N/A	N/A	DWS Length (in)	N/A
N/A	Landing X Slope (%)	N/A	N/A	DWS Full Width?	N/A
N/A	Landing Curb? (Y/N)	N/A	N/A	DWS Offset (in)	N/A
N/A	Shared Landing?	N/A			
N/A	Gutter Ponding?	N/A	N/A	Gutter Slope (%)	N/A
N/A	Gutter Lip Ht (in)	N/A	N/A	Gutter X Slope (%)	N/A
N/A	Painted X Walk1?	No	N/A	Painted X Walk2?	No
	X Walk 1 Direction	To N		X Walk 2 Direction	To SW
N/A	X Walk 1 Width (in)	N/A	N/A	X Walk 2 Width (in)	N/A
	X Walk 1 Slope (%)	2.2		X Walk 2 Slope (%)	2.8
	X Walk 1 X Slope (%)	0.2		X Walk 2 X Slope (%)	2.9

N/A	Ramp inside XWalk1?	N/A	N/A	Ramp inside XWalk2?	N/A
	Road Slope (%)	3.7	N/A	Clear Space?	N/A
	Road X Slope (%)	3.6	N/A	Clear Space to XWalk (in)	N/A
N/A	Any Obstructions?	N/A	N/A	Storm Grate/Utility Hazard?	N/A
	Obstruction Type			Storm Grate/Utility Type	
		N/A			N/A
			Yes	Surface Condition? (G/P)	Good

Remove & Replace Curb Ramp With Two New Directional Ramps or Equivalent.
