# Access Compliance Report

## Public Rights-of-Way

### (Curb Ramps)

Intersection ID: 10027081	Main Street: GALLERIA_BV	Cross Street: N/A	Location: SE
ADA ID: C09EC3184A31	Ramp Type: Perp	Initial Pass/Fail: Fail	Overall Compliance: No
Severity Score: 8.75			
Codes/Mitigation Info/Possible Solution		Field Measurements/Component Compliance

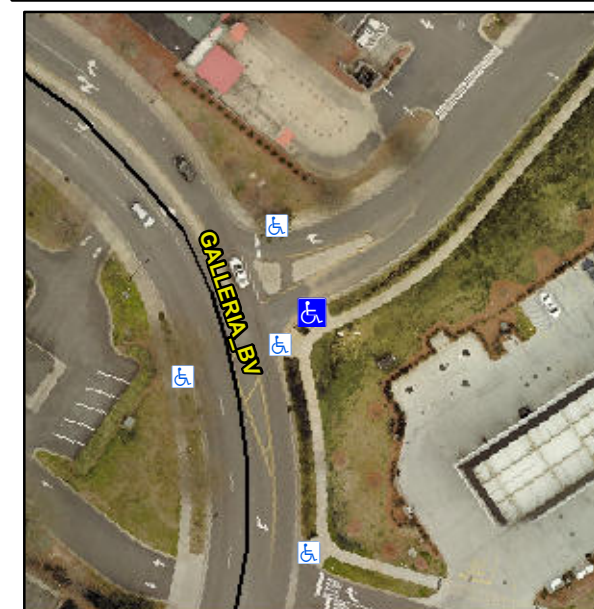
**Not Found, R304.5.1**

Compliance	Description	Data	Compliance	Description	Data
N/A	Ramp Length (in)	96.0	Yes	Ramp Slope (%)	5.9
No	Ramp Width (in)	36.0	Yes	Ramp XSlope (%)	0.1
N/A	Flare Type LT	N/A	N/A	Flare Type RT	N/A
N/A	Flare Slope LT (%)	N/A	N/A	Flare Slope RT (%)	N/A
N/A	Flare Traversable LT?	N/A	N/A	Flare Traversable RT?	N/A
N/A	Landing Length (in)	N/A	N/A	DWS Provided?	N/A
N/A	Landing Width (in)	N/A	N/A	DWS Contrast?	N/A
N/A	Landing Slope (%)	N/A	N/A	DWS Length (in)	N/A
N/A	Landing X Slope (%)	N/A	N/A	DWS Full Width?	N/A
N/A	Landing Curb? (Y/N)	N/A	N/A	DWS Offset (in)	N/A
N/A	Shared Landing?	N/A			
N/A	Gutter Ponding?	N/A	N/A	Gutter Slope (%)	N/A
N/A	Gutter Lip Ht (in)	N/A	N/A	Gutter X Slope (%)	N/A
N/A	Painted X Walk1?	No	N/A	Painted X Walk2?	N/A
	X Walk 1 Direction	To N		X Walk 2 Direction	N/A
N/A	X Walk 1 Width (in)	N/A	N/A	X Walk 2 Width (in)	N/A
	X Walk 1 Slope (%)	2.1		X Walk 2 Slope (%)	N/A
	X Walk 1 X Slope (%)	1.0		X Walk 2 X Slope (%)	N/A

**Remove & Replace Entire Ramp.**
