Intersection ID: 16641	Main Street: IDLEBROOK_DR	Cross Street: MARLBROOK_DR	Location:	SW
ADA ID: C0A85CD8F1A9	Ramp Type: PerpDiag	Initial Pass/Fail: Fail	Overall Compliance: No	Severity Score: 13.75

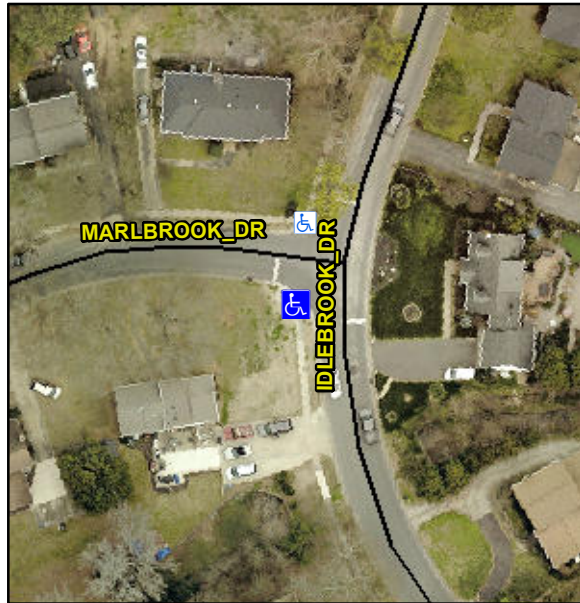
Not Found, R304.2.2, R304.5.3

Compliance	Description	Data	Compliance	Description	Data
N/A	Ramp Length (in)	37.0	No	Ramp Slope (%)	8.4
Yes	Ramp Width (in)	48.0	No	Ramp XSlope (%)	4.8
N/A	Flare Type LT	N/A	N/A	Flare Type RT	N/A
N/A	Flare Slope LT (%)	N/A	N/A	Flare Slope RT (%)	N/A
N/A	Flare Traversable LT?	N/A	N/A	Flare Traversable RT?	N/A
N/A	Landing Length (in)	N/A	N/A	DWS Provided?	N/A
N/A	Landing Width (in)	N/A	N/A	DWS Contrast?	N/A
N/A	Landing Slope (%)	N/A	N/A	DWS Length (in)	N/A
N/A	Landing X Slope (%)	N/A	N/A	DWS Full Width?	N/A
N/A	Landing Curb? (Y/N)	N/A	N/A	DWS Offset (in)	N/A
N/A	Shared Landing?	N/A			
N/A	Gutter Ponding?	N/A	N/A	Gutter Slope (%)	N/A
N/A	Gutter Lip Ht (in)	N/A	N/A	Gutter X Slope (%)	N/A
N/A	Painted X Walk1?	No	N/A	Painted X Walk2?	No
	X Walk 1 Direction	To SE		X Walk 2 Direction	To NE
N/A	X Walk 1 Width (in)	N/A	N/A	X Walk 2 Width (in)	N/A
	X Walk 1 Slope (%)	1.9		X Walk 2 Slope (%)	2.8
	X Walk 1 X Slope (%)	3.2		X Walk 2 X Slope (%)	2.0

N/A	Ramp inside XWalk1?	N/A	N/A	Ramp inside XWalk2?	N/A
	Road Slope (%)	2.5	N/A	Clear Space?	N/A
	Road X Slope (%)	1.4	N/A	Clear Space to XWalk (in)	N/A
N/A	Any Obstructions?	N/A	N/A	Storm Grate/Utility Hazard?	N/A
	Obstruction Type			Storm Grate/Utility Type	
		N/A			N/A
			Yes	Surface Condition? (G/P)	Good

Remove & Replace Curb Ramp With Two New Directional Ramps or Equivalent.
