# Access Compliance Report

## Public Rights-of-Way

| Intersection ID: 8132 | Main Street: OLD_CONCORD_RD | Cross Street: BRANCH_HILL_CR | Location: W |
| ADA ID: C0A936EC2944 | Ramp Type: Perp | Initial Pass/Fail: Pass | Overall Compliance: No |

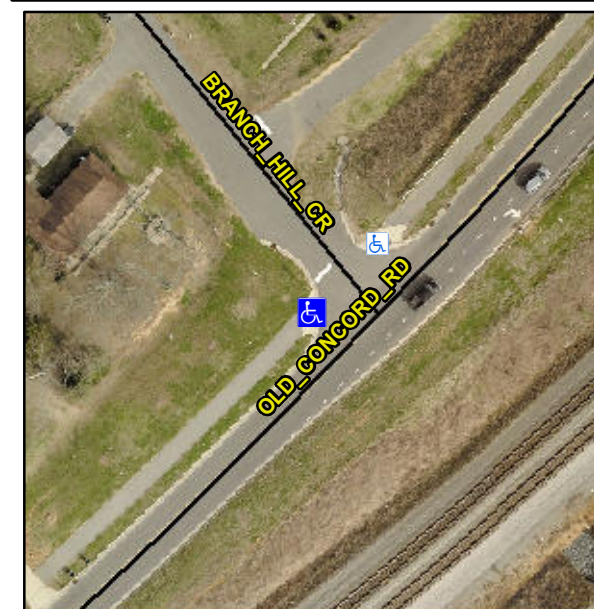
**Not Found, R304.2.1, R304.2.2-Perp,  
R304.3.2-Para, R304.5.3, R305.1.4,  
R302.7, R304.5.4**

| Compliance | Description | Data | Compliance | Description | Data |
|---|---|---|---|---|---|
| No | Landing Width (in) | 24.0 | Yes | DWS Contrast? | Yes |
| No | Landing Slope (%) | 5.0 | No | DWS Length (in) | 23.5 |
| No | Landing X Slope (%) | 3.3 | Yes | DWS Full Width? | Yes |
| No | Gutter Ponding? | Yes | No | Gutter Slope (%) | 7.3 |

**Remove & Replace Entire Ramp.  
Remove & Replace Gutter.**
