Access Compliance Report

Public Rights-of-Way

(Curb Ramps)

Intersection ID: 3052	Main Street: FOX_GLEN_RD	Cross Street: GLENOVER_CR	Location: S
ADA ID: C0B0EB9AD2A3	Ramp Type: Perp	Initial Pass/Fail: Fail	Overall Compliance: No
Severity Score: 26.25			
Codes/Mitigation Info/Possible Solution		Field Measurements/Component Compliance

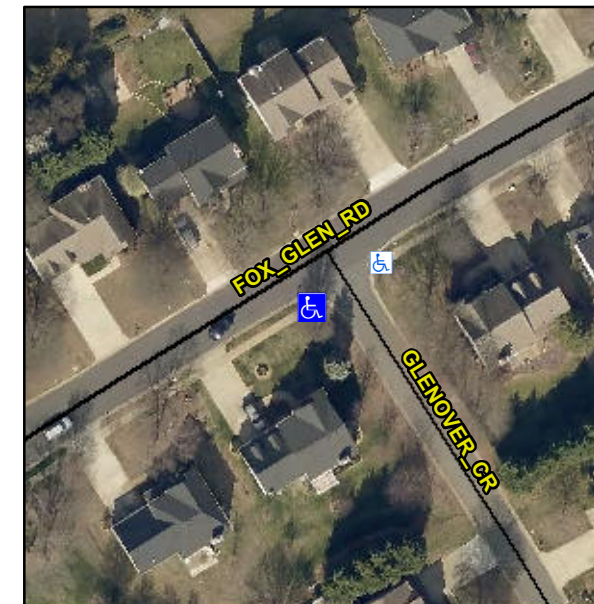
Not Found, R304.2.2, R304.5.3

Compliance	Description	Data	Compliance	Description	Data
N/A	Ramp Length (in)	18.0	No	Ramp Slope (%)	12.7
Yes	Ramp Width (in)	48.0	No	Ramp XSlope (%)	2.7
N/A	Flare Type LT	N/A	N/A	Flare Type RT	N/A
N/A	Flare Slope LT (%)	N/A	N/A	Flare Slope RT (%)	N/A
N/A	Flare Traversable LT?	N/A	N/A	Flare Traversable RT?	N/A
N/A	Landing Length (in)	N/A	N/A	DWS Provided?	N/A
N/A	Landing Width (in)	N/A	N/A	DWS Contrast?	N/A
N/A	Landing Slope (%)	N/A	N/A	DWS Length (in)	N/A
N/A	Landing X Slope (%)	N/A	N/A	DWS Full Width?	N/A
N/A	Landing Curb? (Y/N)	N/A	N/A	DWS Offset (in)	N/A
N/A	Shared Landing?	N/A			
N/A	Gutter Ponding?	N/A	N/A	Gutter Slope (%)	N/A
N/A	Gutter Lip Ht (in)	N/A	N/A	Gutter X Slope (%)	N/A
N/A	Painted X Walk1?	No	N/A	Painted X Walk2?	N/A
	X Walk 1 Direction	To NE		X Walk 2 Direction	N/A
N/A	X Walk 1 Width (in)	N/A	N/A	X Walk 2 Width (in)	N/A
	X Walk 1 Slope (%)	1.0		X Walk 2 Slope (%)	N/A
	X Walk 1 X Slope (%)	6.9		X Walk 2 X Slope (%)	N/A

N/A	Ramp inside XWalk1?	N/A	N/A	Ramp inside XWalk2?	N/A
	Road Slope (%)	N/A	N/A	Clear Space?	N/A
	Road X Slope (%)	N/A	N/A	Clear Space to XWalk (in)	N/A
N/A	Any Obstructions?	N/A	N/A	Storm Grate/Utility Hazard?	N/A
	Obstruction Type			Storm Grate/Utility Type	
		N/A			N/A
			Yes	Surface Condition? (G/P)	Good

Possible Solutions:

Remove & Replace Entire Ramp.
