Intersection ID: 13007	Main Street: HAWTHORNE_LN	Cross Street: CENTRAL_AV	Location:	NW
ADA ID: C0B61E00A8E0	Ramp Type: PerpDiag	Initial Pass/Fail: Fail	Overall Compliance: No	Severity Score: 46.25

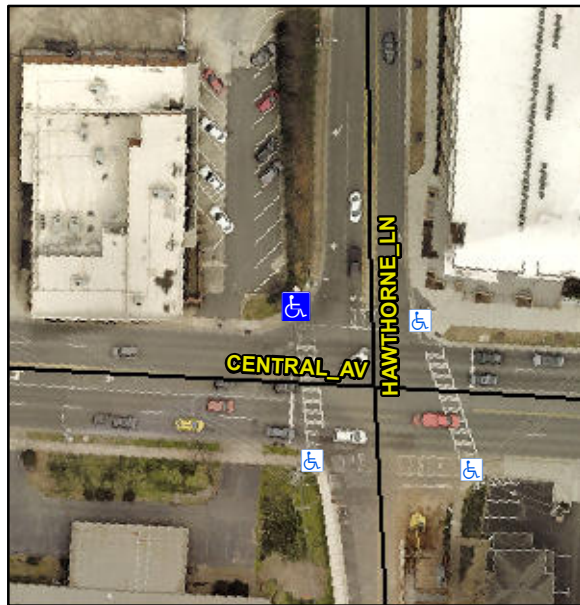
**Not Found, R304.5.1, R304.2.2,
R304.5.3**

Compliance	Description	Data	Compliance	Description	Data
N/A	Ramp Length (in)	60.0	No	Ramp Slope (%)	10.1
No	Ramp Width (in)	40.0	No	Ramp XSlope (%)	7.3
N/A	Flare Type LT	N/A	N/A	Flare Type RT	N/A
N/A	Flare Slope LT (%)	N/A	N/A	Flare Slope RT (%)	N/A
N/A	Flare Traversable LT?	N/A	N/A	Flare Traversable RT?	N/A
N/A	Landing Length (in)	N/A	N/A	DWS Provided?	N/A
N/A	Landing Width (in)	N/A	N/A	DWS Contrast?	N/A
N/A	Landing Slope (%)	N/A	N/A	DWS Length (in)	N/A
N/A	Landing X Slope (%)	N/A	N/A	DWS Full Width?	N/A
N/A	Landing Curb? (Y/N)	N/A	N/A	DWS Offset (in)	N/A
N/A	Shared Landing?	N/A			
N/A	Gutter Ponding?	N/A	N/A	Gutter Slope (%)	N/A
N/A	Gutter Lip Ht (in)	0.5	N/A	Gutter X Slope (%)	N/A
N/A	Painted X Walk1?	Yes	N/A	Painted X Walk2?	Yes
	X Walk 1 Direction	To S		X Walk 2 Direction	To E
N/A	X Walk 1 Width (in)	105.0	N/A	X Walk 2 Width (in)	105.0
	X Walk 1 Slope (%)	5.6		X Walk 2 Slope (%)	4.9
	X Walk 1 X Slope (%)	3.5		X Walk 2 X Slope (%)	6.6

N/A	Ramp inside XWalk1?	Yes	N/A	Ramp inside XWalk2?	Yes
	Road Slope (%)	7.6	N/A	Clear Space?	N/A
	Road X Slope (%)	0.0	N/A	Clear Space to XWalk (in)	N/A
N/A	Any Obstructions?	N/A	N/A	Storm Grate/Utility Hazard?	N/A
	Obstruction Type			Storm Grate/Utility Type	
		N/A			N/A
			Yes	Surface Condition? (G/P)	Good

Possible Solutions:

Remove & Replace Curb Ramp With Two New Directional Ramps or Equivalent.
