# Access Compliance Report

## Public Rights-of-Way

| Intersection ID: 44265 | Main Street: LAWING_SCHOOL_RD | Cross Street: EMILY_HOPE_DR | Location: | N |
| ADA ID: C0C081548C31 | Ramp Type: Perp | Initial Pass/Fail: Fail | Overall Compliance: No | Severity Score: 22.5 |

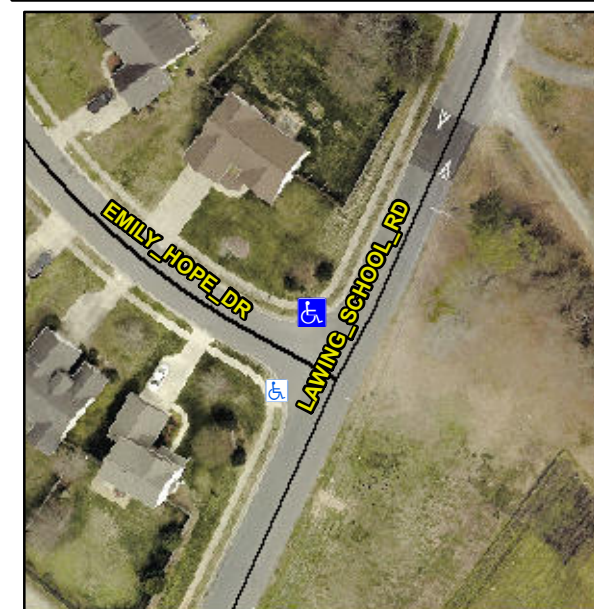
**Not Found, R304.5.1, R304.2.2, R304.5.3**

| Compliance | Description | Data | Compliance | Description | Data |
|---|---|---|---|---|---|
| N/A | Ramp Length (in) | 48.0 | No | Ramp Slope (%) | 11.1 |
| No | Ramp Width (in) | 40.0 | No | Ramp XSlope (%) | 2.4 |

**Remove & Replace Entire Ramp.**
