# Access Compliance Report

## Public Rights-of-Way

### (Curb Ramps)

Intersection ID: 43738	Main Street: BRIDGEMOUNT_AV	Cross Street: ELIZABETH_MADISON_CT	Location: SE
ADA ID: C0C18BB041C6	Ramp Type: Perp	Initial Pass/Fail: Fail	Overall Compliance: No
Severity Score: 46.25			
Codes/Mitigation Info/Possible Solution		Field Measurements/Component Compliance

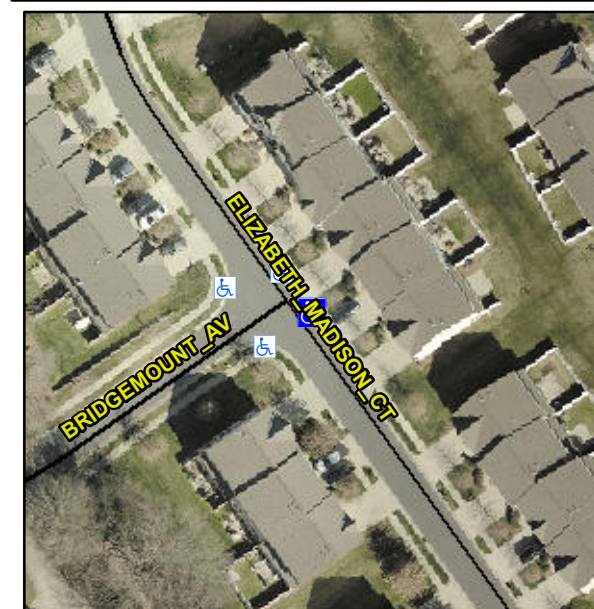
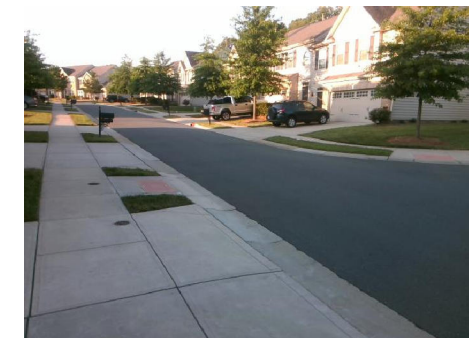
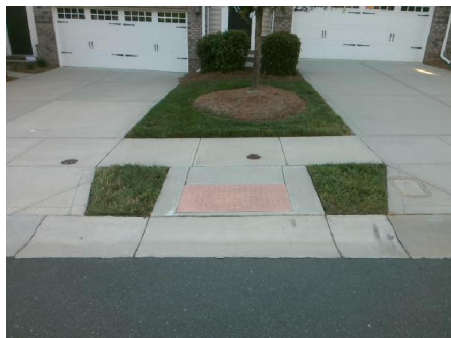
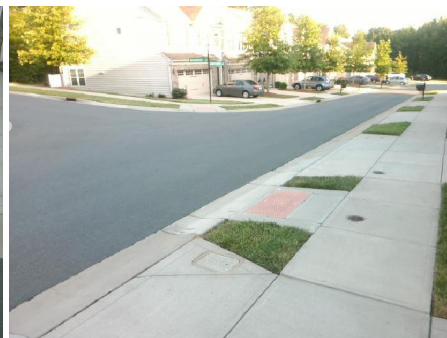
**Not Found, R304.5.1, R304.2.2, R304.5.3**

Compliance	Description	Data	Compliance	Description	Data
N/A	Ramp Length (in)	47.5	No	Ramp Slope (%)	8.9
No	Ramp Width (in)	47.5	No	Ramp XSlope (%)	7.0
N/A	Flare Type LT	N/A	N/A	Flare Type RT	N/A
N/A	Flare Slope LT (%)	N/A	N/A	Flare Slope RT (%)	N/A
N/A	Flare Traversable LT?	N/A	N/A	Flare Traversable RT?	N/A
N/A	Landing Length (in)	N/A	N/A	DWS Provided?	N/A
N/A	Landing Width (in)	N/A	N/A	DWS Contrast?	N/A
N/A	Landing Slope (%)	N/A	N/A	DWS Length (in)	N/A
N/A	Landing X Slope (%)	N/A	N/A	DWS Full Width?	N/A
N/A	Landing Curb? (Y/N)	N/A	N/A	DWS Offset (in)	N/A
N/A	Shared Landing?	N/A			
N/A	Gutter Ponding?	N/A	N/A	Gutter Slope (%)	N/A
N/A	Gutter Lip Ht (in)	N/A	N/A	Gutter X Slope (%)	N/A
N/A	Painted X Walk1?	No	N/A	Painted X Walk2?	N/A
	X Walk 1 Direction	To SW		X Walk 2 Direction	N/A
N/A	X Walk 1 Width (in)	N/A	N/A	X Walk 2 Width (in)	N/A
	X Walk 1 Slope (%)	4.5		X Walk 2 Slope (%)	N/A
	X Walk 1 X Slope (%)	5.3		X Walk 2 X Slope (%)	N/A

N/A	Ramp inside XWalk1?	N/A	N/A	Ramp inside XWalk2?	N/A
	Road Slope (%)	N/A	N/A	Clear Space?	N/A
	Road X Slope (%)	N/A	N/A	Clear Space to XWalk (in)	N/A
N/A	Any Obstructions?	N/A	N/A	Storm Grate/Utility Hazard?	N/A
	Obstruction Type			Storm Grate/Utility Type	
		N/A			N/A
			Yes	Surface Condition? (G/P)	Good

**Remove & Replace Entire Ramp.**

Total Cost: \$ 1850.00
