Access Compliance Report

Public Rights-of-Way

(Curb Ramps)

Intersection ID: 47278	Main Street: BERNADINE_CT	Cross Street: CARRINGTON_FOREST_LN	Location: NE
ADA ID: C0C53D4FB804	Ramp Type: Perp	Initial Pass/Fail: Fail	Overall Compliance: No
			Severity Score: 10

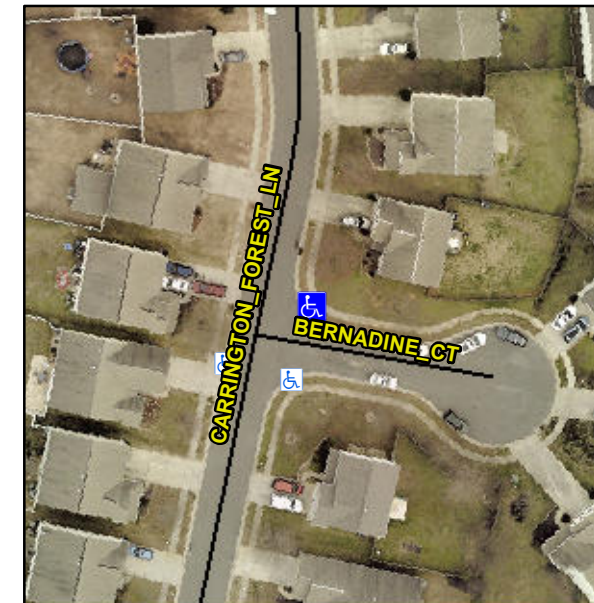
Not Found, R304.5.1, R304.5.3

Compliance	Description	Data	Compliance	Description	Data
N/A	Ramp Length (in)	47.5	Yes	Ramp Slope (%)	5.4
No	Ramp Width (in)	43.0	No	Ramp XSlope (%)	4.9
N/A	Flare Type LT	N/A	N/A	Flare Type RT	N/A
N/A	Flare Slope LT (%)	N/A	N/A	Flare Slope RT (%)	N/A
N/A	Flare Traversable LT?	N/A	N/A	Flare Traversable RT?	N/A
N/A	Landing Length (in)	N/A	N/A	DWS Provided?	N/A
N/A	Landing Width (in)	N/A	N/A	DWS Contrast?	N/A
N/A	Landing Slope (%)	N/A	N/A	DWS Length (in)	N/A
N/A	Landing X Slope (%)	N/A	N/A	DWS Full Width?	N/A
N/A	Landing Curb? (Y/N)	N/A	N/A	DWS Offset (in)	N/A
N/A	Shared Landing?	N/A			
N/A	Gutter Ponding?	N/A	N/A	Gutter Slope (%)	N/A
N/A	Gutter Lip Ht (in)	N/A	N/A	Gutter X Slope (%)	N/A
N/A	Painted X Walk1?	No	N/A	Painted X Walk2?	N/A
	X Walk 1 Direction	To S		X Walk 2 Direction	N/A
N/A	X Walk 1 Width (in)	N/A	N/A	X Walk 2 Width (in)	N/A
	X Walk 1 Slope (%)	3.6		X Walk 2 Slope (%)	N/A
	X Walk 1 X Slope (%)	2.8		X Walk 2 X Slope (%)	N/A

N/A	Ramp inside XWalk1?	N/A	N/A	Ramp inside XWalk2?	N/A
	Road Slope (%)	4.3	N/A	Clear Space?	N/A
	Road X Slope (%)	0.2	N/A	Clear Space to XWalk (in)	N/A
N/A	Any Obstructions?	N/A	N/A	Storm Grate/Utility Hazard?	N/A
	Obstruction Type			Storm Grate/Utility Type	
		N/A			N/A
			Yes	Surface Condition? (G/P)	Good

Remove & Replace Entire Ramp.
