Access Compliance Report

Public Rights-of-Way

(Curb Ramps)

Intersection ID: 14356	Main Street: BAXTER_ST	Cross Street: S_TORRENCE_ST	Location: S
ADA ID: C0E672CD3C7D	Ramp Type: PerpDiag	Initial Pass/Fail: Fail	Overall Compliance: No
		Severity Score: 37.5

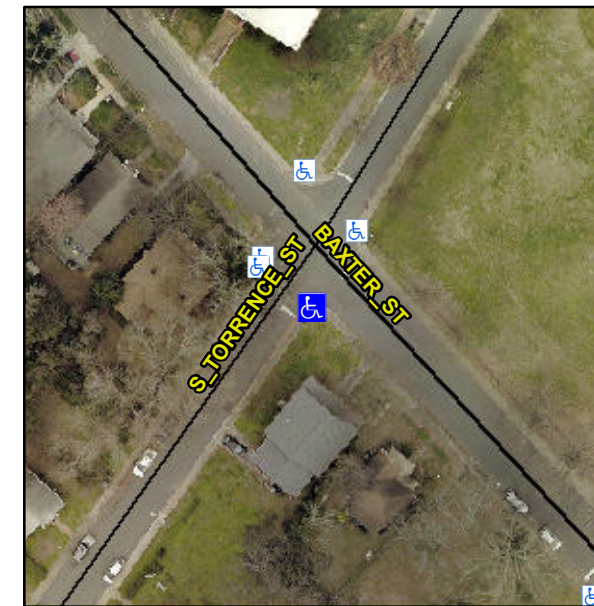
Compliance	Description	Data	Compliance	Description	Data
N/A	Ramp Length (in)	53.0	No	Ramp Slope (%)	15.4
Yes	Ramp Width (in)	48.0	No	Ramp XSlope (%)	5.8
N/A	Flare Type LT	N/A	N/A	Flare Type RT	N/A
N/A	Flare Slope LT (%)	N/A	N/A	Flare Slope RT (%)	N/A
N/A	Flare Traversable LT?	N/A	N/A	Flare Traversable RT?	N/A
N/A	Landing Length (in)	N/A	N/A	DWS Provided?	N/A
N/A	Landing Width (in)	N/A	N/A	DWS Contrast?	N/A
N/A	Landing Slope (%)	N/A	N/A	DWS Length (in)	N/A
N/A	Landing X Slope (%)	N/A	N/A	DWS Full Width?	N/A
N/A	Landing Curb? (Y/N)	N/A	N/A	DWS Offset (in)	N/A
N/A	Shared Landing?	N/A			
N/A	Gutter Ponding?	N/A	N/A	Gutter Slope (%)	N/A
N/A	Gutter Lip Ht (in)	N/A	N/A	Gutter X Slope (%)	N/A
N/A	Painted X Walk1?	No	N/A	Painted X Walk2?	No
	X Walk 1 Direction	To NE		X Walk 2 Direction	To NW
N/A	X Walk 1 Width (in)	N/A	N/A	X Walk 2 Width (in)	N/A
	X Walk 1 Slope (%)	5.3		X Walk 2 Slope (%)	0.5
	X Walk 1 X Slope (%)	2.0		X Walk 2 X Slope (%)	6.3

N/A	Ramp inside XWalk1?	N/A	N/A	Ramp inside XWalk2?	N/A
	Road Slope (%)	5.7	N/A	Clear Space?	N/A
	Road X Slope (%)	6.9	N/A	Clear Space to XWalk (in)	N/A
N/A	Any Obstructions?	N/A	N/A	Storm Grate/Utility Hazard?	N/A
	Obstruction Type			Storm Grate/Utility Type	
		N/A			N/A
			Yes	Surface Condition? (G/P)	Good

Possible Solutions:

Remove & Replace Curb Ramp With Two New Directional Ramps or Equivalent.

R304.2.2, R304.5.3
