Access Compliance Report

Public Rights-of-Way

(Curb Ramps)

Intersection ID: 53922	Main Street: ERICA_WOODS_LN	Cross Street: PINYON_PINE_LN	Location: SW
ADA ID: C0E7E264A3FE	Ramp Type: PerpDiag	Initial Pass/Fail: Fail	Overall Compliance: No
Severity Score: 48.75			
Codes/Mitigation Info/Possible Solution		Field Measurements/Component Compliance

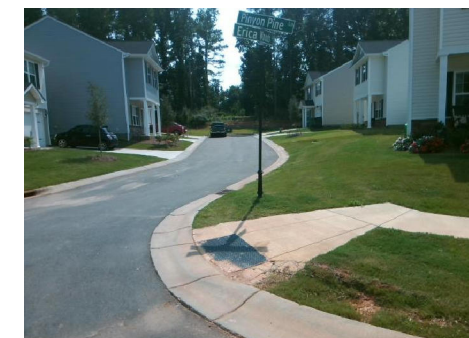
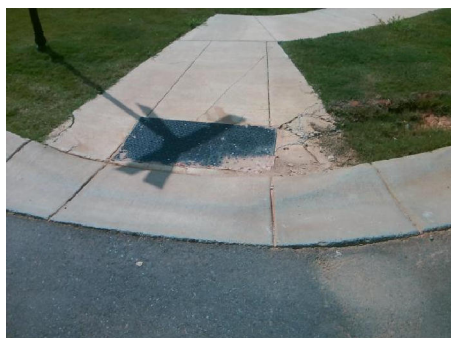
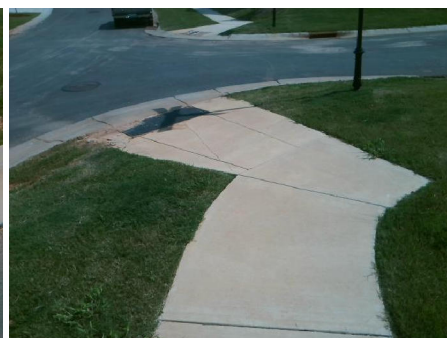
Not Found, R304.5.1, R304.2.2, R304.5.3

Compliance	Description	Data	Compliance	Description	Data
N/A	Ramp Length (in)	99.0	No	Ramp Slope (%)	8.9
No	Ramp Width (in)	27.0	No	Ramp XSlope (%)	3.3
N/A	Flare Type LT	N/A	N/A	Flare Type RT	N/A
N/A	Flare Slope LT (%)	N/A	N/A	Flare Slope RT (%)	N/A
N/A	Flare Traversable LT?	N/A	N/A	Flare Traversable RT?	N/A
N/A	Landing Length (in)	N/A	N/A	DWS Provided?	N/A
N/A	Landing Width (in)	N/A	N/A	DWS Contrast?	N/A
N/A	Landing Slope (%)	N/A	N/A	DWS Length (in)	N/A
N/A	Landing X Slope (%)	N/A	N/A	DWS Full Width?	N/A
N/A	Landing Curb? (Y/N)	N/A	N/A	DWS Offset (in)	N/A
N/A	Shared Landing?	N/A			
N/A	Gutter Ponding?	N/A	N/A	Gutter Slope (%)	N/A
N/A	Gutter Lip Ht (in)	1.0	N/A	Gutter X Slope (%)	N/A
N/A	Painted X Walk1?	No	N/A	Painted X Walk2?	No
	X Walk 1 Direction	To NE		X Walk 2 Direction	To N
N/A	X Walk 1 Width (in)	N/A	N/A	X Walk 2 Width (in)	N/A
	X Walk 1 Slope (%)	4.4		X Walk 2 Slope (%)	2.7
	X Walk 1 X Slope (%)	1.8		X Walk 2 X Slope (%)	0.5

N/A	Ramp inside XWalk1?	N/A	N/A	Ramp inside XWalk2?	N/A
	Road Slope (%)	2.6	N/A	Clear Space?	N/A
	Road X Slope (%)	3.5	N/A	Clear Space to XWalk (in)	N/A
N/A	Any Obstructions?	N/A	N/A	Storm Grate/Utility Hazard?	N/A
	Obstruction Type			Storm Grate/Utility Type	
		N/A			N/A
			Yes	Surface Condition? (G/P)	Good

Possible Solutions:

Remove & Replace Curb Ramp With Two New Directional Ramps or Equivalent.
