Access Compliance Report

Public Rights-of-Way

(Curb Ramps)

Intersection ID: 30176	Main Street: FAIRSTONE_AV	Cross Street: MENTONE_LN	Location:	N
ADA ID: C0FB98145E29	Ramp Type: BlendTrans1	Initial Pass/Fail: Fail	Overall Compliance: No	Severity Score: 8.75

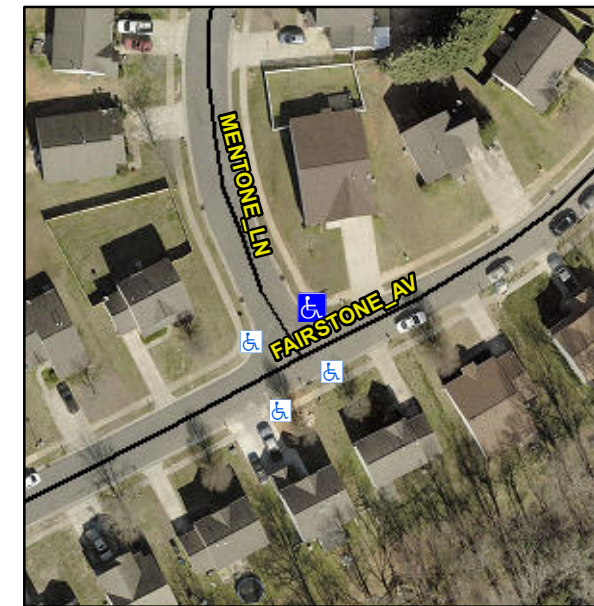
Not Found, R304.5.1

Compliance	Description	Data	Compliance	Description	Data
N/A	Ramp Length (in)	49.5	Yes	BlendTrans Slope (%)	3.8
No	Ramp Width (in)	47.0	Yes	BlendTrans XSlope (%)	0.6
N/A	Flare Type LT	N/A	N/A	Flare Type RT	N/A
N/A	Flare Slope LT (%)	N/A	N/A	Flare Slope RT (%)	N/A
N/A	Flare Traversable LT?	N/A	N/A	Flare Traversable RT?	N/A
N/A	Landing Length (in)	N/A	N/A	DWS Provided?	N/A
N/A	Landing Width (in)	N/A	N/A	DWS Contrast?	N/A
N/A	Landing Slope (%)	N/A	N/A	DWS Length (in)	N/A
N/A	Landing X Slope (%)	N/A	N/A	DWS Full Width?	N/A
N/A	Landing Curb? (Y/N)	N/A	N/A	DWS Offset (in)	N/A
N/A	Shared Landing?	N/A			
N/A	Gutter Ponding?	N/A	N/A	Gutter Slope (%)	N/A
N/A	Gutter Lip Ht (in)	1.5	N/A	Gutter X Slope (%)	N/A
N/A	Painted X Walk1?	No	N/A	Painted X Walk2?	No
	X Walk 1 Direction	To SW		X Walk 2 Direction	To SE
	X Walk 1 Width (in)	N/A		X Walk 2 Width (in)	N/A
	X Walk 1 Slope (%)	4.3		X Walk 2 Slope (%)	0.9
	X Walk 1 X Slope (%)	1.9		X Walk 2 X Slope (%)	1.5

N/A	Ramp inside XWalk1?	N/A	N/A	Ramp inside XWalk2?	N/A
	Road Slope (%)	0.5		Clear Space?	N/A
	Road X Slope (%)	1.7	N/A	Clear Space to XWalk (in)	N/A
N/A	Any Obstructions?	N/A	N/A	Storm Grate/Utility Hazard?	N/A
	Obstruction Type			Storm Grate/Utility Type	
		N/A			N/A
			Yes	Surface Condition? (G/P)	Good
			No	Curb Slope (%)	13.5

Remove & Replace Curb Ramp With Two New Directional Ramps or Equivalent.
