# Access Compliance Report

## Public Rights-of-Way

### (Curb Ramps)

Intersection ID: 6578	Main Street: CAPPS_HILL_DR	Cross Street: CAPPS_HILL_MINE_RD	Location: SW
ADA ID: C100B6AC7CC2	Ramp Type: BlendTrans1	Initial Pass/Fail: Fail	Overall Compliance: No
		Severity Score: 25

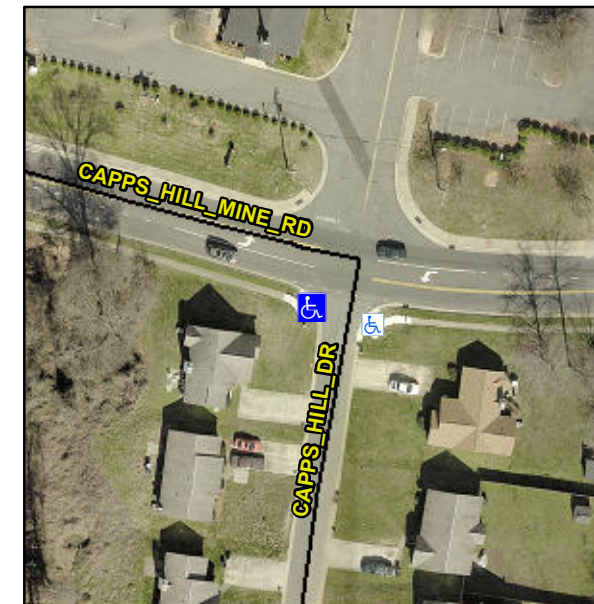
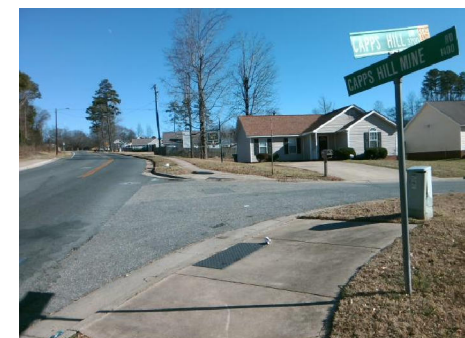
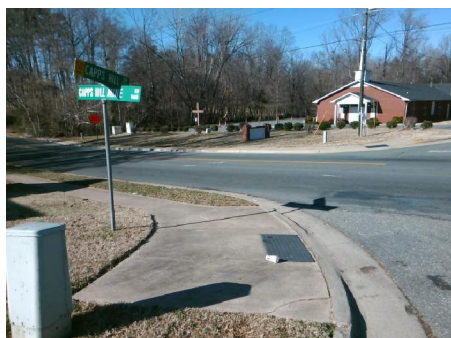
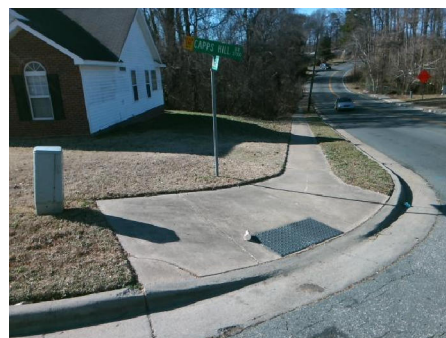
**Not Found, R304.5.3**

Compliance	Description	Data	Compliance	Description	Data
N/A	Ramp Length (in)	96.0	Yes	BlendTrans Slope (%)	4.7
Yes	Ramp Width (in)	59.0	No	BlendTrans XSlope (%)	8.0
N/A	Flare Type LT	N/A	N/A	Flare Type RT	N/A
N/A	Flare Slope LT (%)	N/A	N/A	Flare Slope RT (%)	N/A
N/A	Flare Traversable LT?	N/A	N/A	Flare Traversable RT?	N/A
N/A	Landing Length (in)	N/A	N/A	DWS Provided?	N/A
N/A	Landing Width (in)	N/A	N/A	DWS Contrast?	N/A
N/A	Landing Slope (%)	N/A	N/A	DWS Length (in)	N/A
N/A	Landing X Slope (%)	N/A	N/A	DWS Full Width?	N/A
N/A	Landing Curb? (Y/N)	N/A	N/A	DWS Offset (in)	N/A
N/A	Shared Landing?	N/A			
N/A	Gutter Ponding?	N/A	N/A	Gutter Slope (%)	N/A
N/A	Gutter Lip Ht (in)	N/A	N/A	Gutter X Slope (%)	N/A
N/A	Painted X Walk1?	No	N/A	Painted X Walk2?	N/A
	X Walk 1 Direction	To E		X Walk 2 Direction	N/A
	X Walk 1 Width (in)	N/A		X Walk 2 Width (in)	N/A
	X Walk 1 Slope (%)	9.9		X Walk 2 Slope (%)	N/A
	X Walk 1 X Slope (%)	0.1		X Walk 2 X Slope (%)	N/A

N/A	Ramp inside XWalk1?	N/A	N/A	Ramp inside XWalk2?	N/A
	Road Slope (%)	0.1		Clear Space?	N/A
	Road X Slope (%)	9.9	N/A	Clear Space to XWalk (in)	N/A
N/A	Any Obstructions?	N/A	N/A	Storm Grate/Utility Hazard?	N/A
	Obstruction Type			Storm Grate/Utility Type	
		N/A			N/A
			Yes	Surface Condition? (G/P)	Good
			No	Curb Slope (%)	13.0

**Remove & Replace Curb Ramp With Two New Directional Ramps or Equivalent.**

Total Cost: \$ 3200.00
