# Access Compliance Report

## Public Rights-of-Way

### (Curb Ramps)

Intersection ID: 52304	Main Street: IMPATIE_N_DR	Cross Street: SNOWBELL_CT	Location: SE
ADA ID: C110C7198A27	Ramp Type: PerpDiag	Initial Pass/Fail: Fail	Overall Compliance: No
Severity Score: 10			
Codes/Mitigation Info/Possible Solution		Field Measurements/Component Compliance

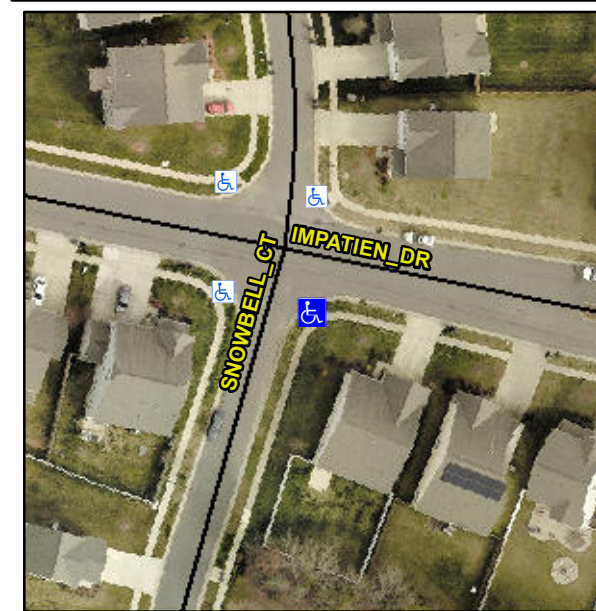
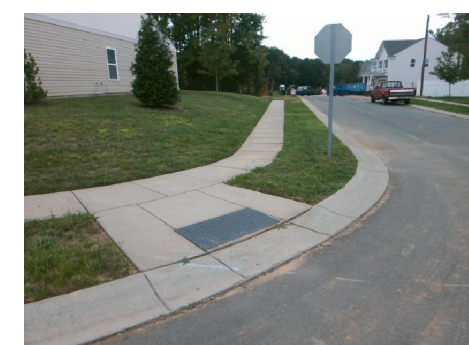
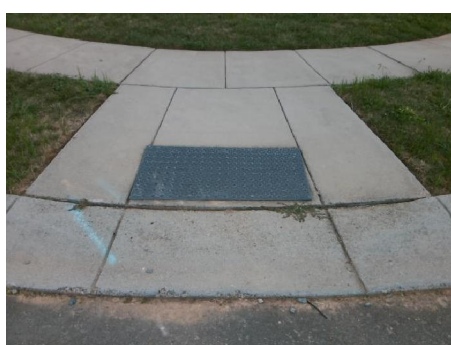
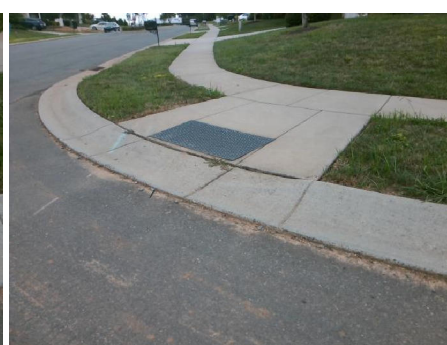
**Not Found, R304.5.1, R304.5.3**

Compliance	Description	Data	Compliance	Description	Data
N/A	Ramp Length (in)	70.5	Yes	Ramp Slope (%)	7.7
No	Ramp Width (in)	39.5	No	Ramp XSlope (%)	2.6
N/A	Flare Type LT	N/A	N/A	Flare Type RT	N/A
N/A	Flare Slope LT (%)	N/A	N/A	Flare Slope RT (%)	N/A
N/A	Flare Traversable LT?	N/A	N/A	Flare Traversable RT?	N/A
N/A	Landing Length (in)	N/A	N/A	DWS Provided?	N/A
N/A	Landing Width (in)	N/A	N/A	DWS Contrast?	N/A
N/A	Landing Slope (%)	N/A	N/A	DWS Length (in)	N/A
N/A	Landing X Slope (%)	N/A	N/A	DWS Full Width?	N/A
N/A	Landing Curb? (Y/N)	N/A	N/A	DWS Offset (in)	N/A
N/A	Shared Landing?	N/A			
N/A	Gutter Ponding?	N/A	N/A	Gutter Slope (%)	N/A
N/A	Gutter Lip Ht (in)	1.0	N/A	Gutter X Slope (%)	N/A
N/A	Painted X Walk1?	No	N/A	Painted X Walk2?	No
	X Walk 1 Direction	To N		X Walk 2 Direction	To W
N/A	X Walk 1 Width (in)	N/A	N/A	X Walk 2 Width (in)	N/A
	X Walk 1 Slope (%)	1.4		X Walk 2 Slope (%)	1.9
	X Walk 1 X Slope (%)	2.1		X Walk 2 X Slope (%)	0.1

N/A	Ramp inside XWalk1?	N/A	N/A	Ramp inside XWalk2?	N/A
	Road Slope (%)	0.9	N/A	Clear Space?	N/A
	Road X Slope (%)	0.4	N/A	Clear Space to XWalk (in)	N/A
N/A	Any Obstructions?	N/A	N/A	Storm Grate/Utility Hazard?	N/A
	Obstruction Type			Storm Grate/Utility Type	
		N/A			N/A
		Yes		Surface Condition? (G/P)	Good

**Remove & Replace Curb Ramp With Two New Directional Ramps or Equivalent.**
